# BRUSSELS HERITAGE

SPECIAL EDITION – 2018

La Grand-Place, Brussels  
inscribed on the World  
Heritage List in 1998

## THE RESTORATION OF AN EXCEPTIONAL DECORATIVE ENVIRONMENT

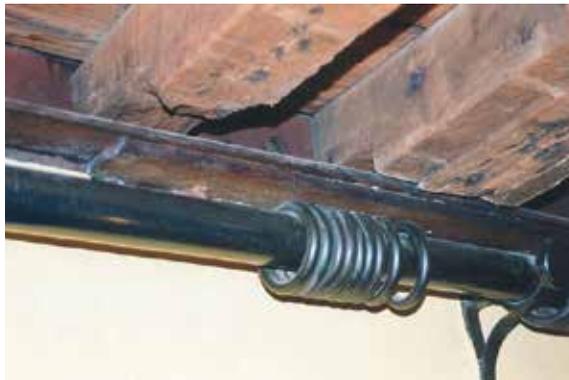
incorporated into the stone facing, are not generally visible, except in No 23, *L'Ange/Den Engel*, where one of the corner pieces used to support the structure supporting the floors can still be seen at the mezzanine level.

L'Ange/Den Engel - mezzanine, steel corner pieces bearing the old floor supporting structure (© HHU, 1999).

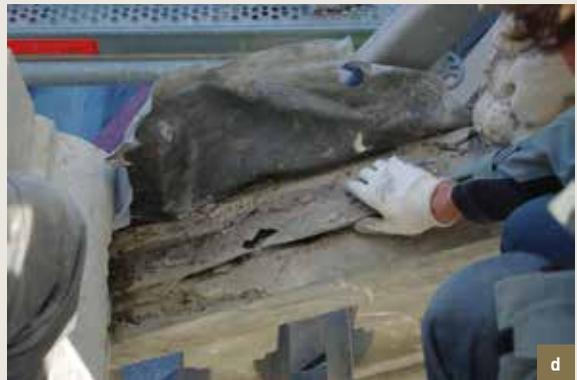
*La Chaloupe d'Or/De Gulden Boot.* a) Left side aileron with flower motifs. The element is becoming detached and sliding outwards as a result of a corroding metal pin; b) Idem. Right section. Installation of temporary protective net following the inspection, while awaiting the restoration work; c) Displacement of right pinnacle of gable; d) Idem on left side. Beneath the lead, rust can be seen on the metal pin causing the aforementioned problems (© HHU, 2000).

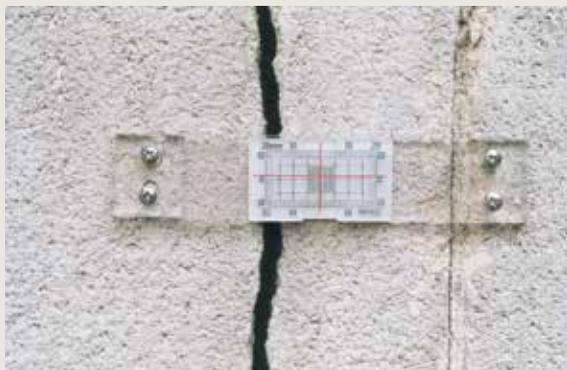
Installation of crack measuring apparatus in different areas following the schedules of condition and the observation of the presence of cracks. The image shows the façade of *Le Cerf/De Heert*. Euville stone (© HHU, 2000).

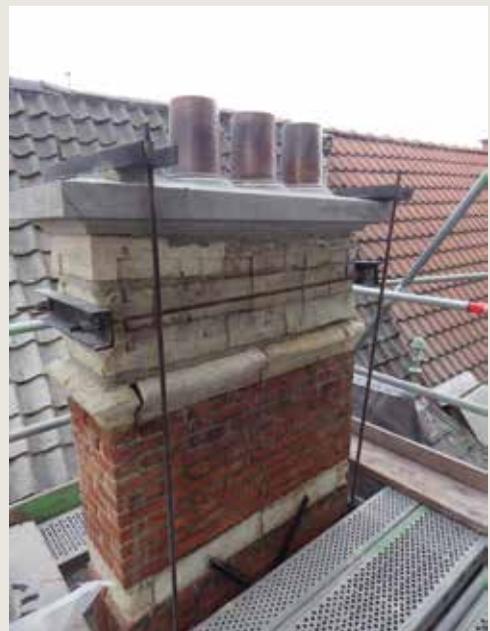
*Le Heaume/Den Helm.* Bracing of chimney after detection of instability (© HHU, 2000).

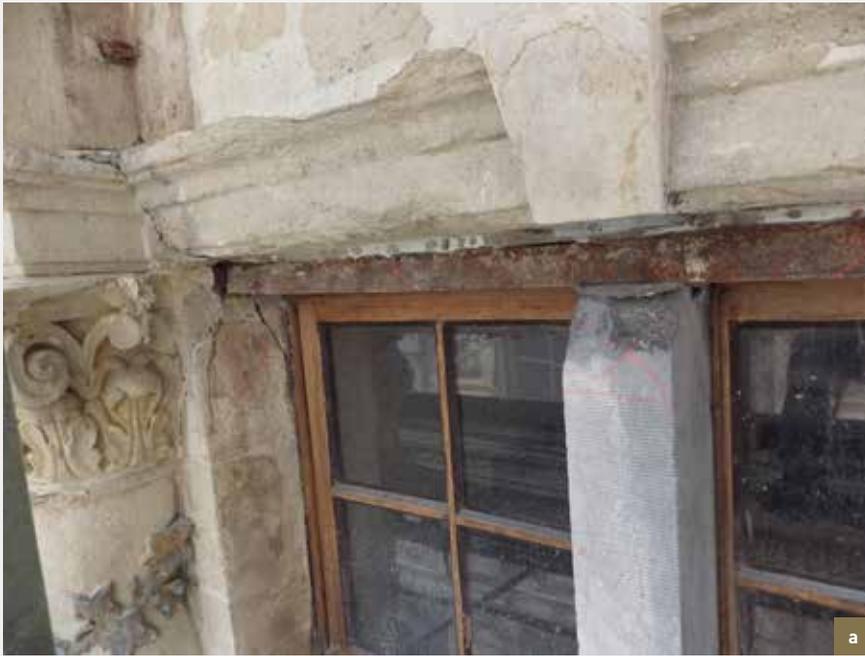
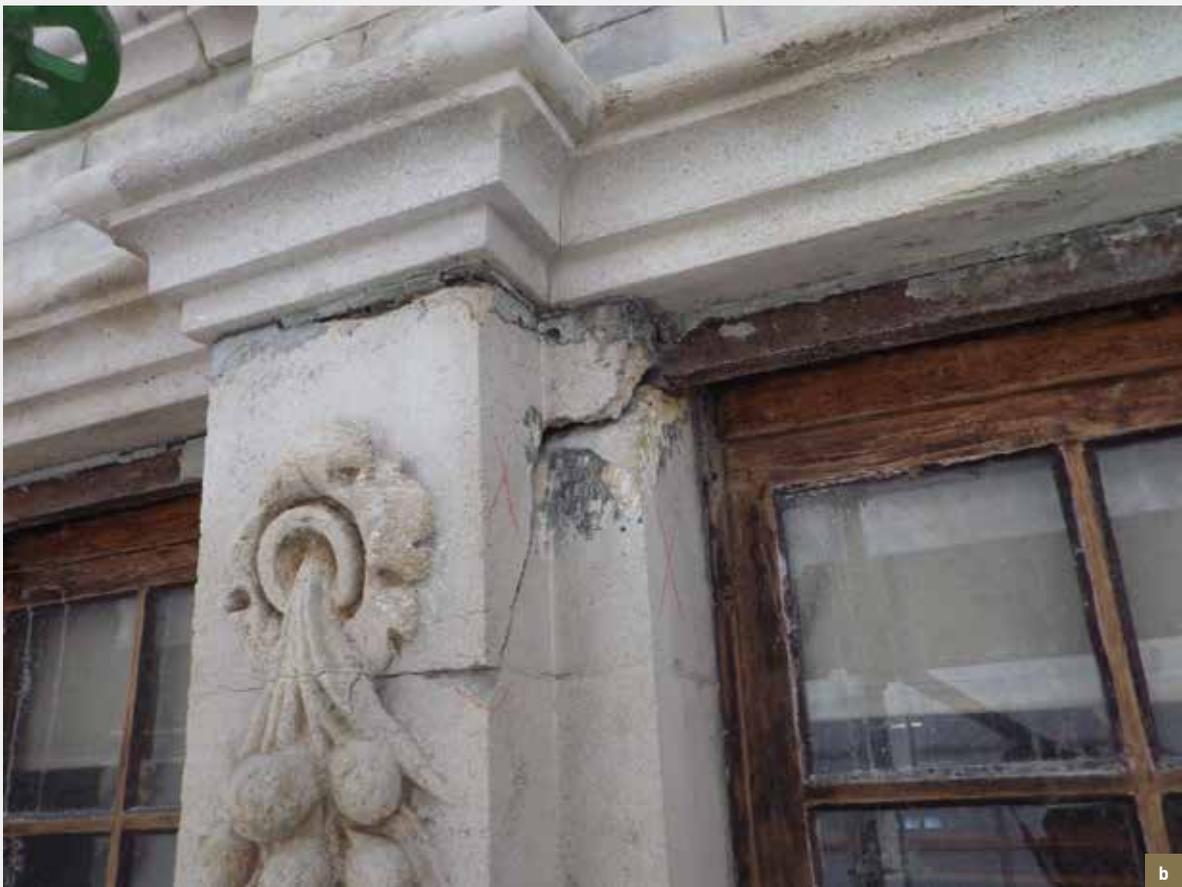
*La Brouette/Den Cruywagen.* Square metal bars dividing the lintels. The corrosion of the bars is causing the stone to fracture. a) Fracturing of elements made from blue stone and Balegem stone. Photographs taken during the restoration; b) Fracturing of an element made from Euville stone (© HHU, 2014).

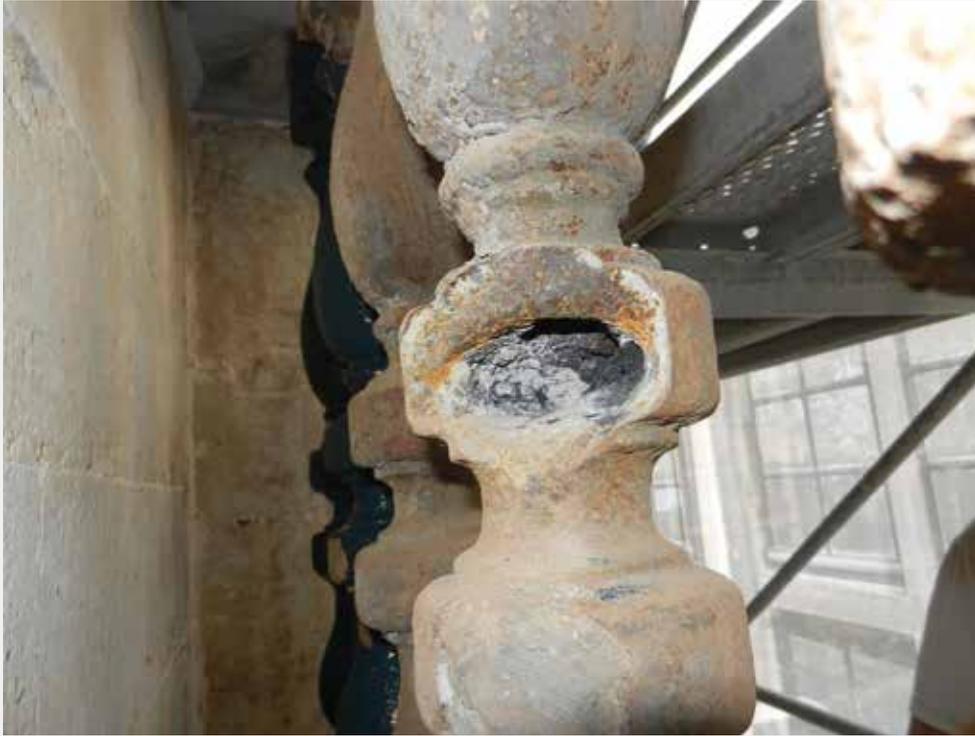
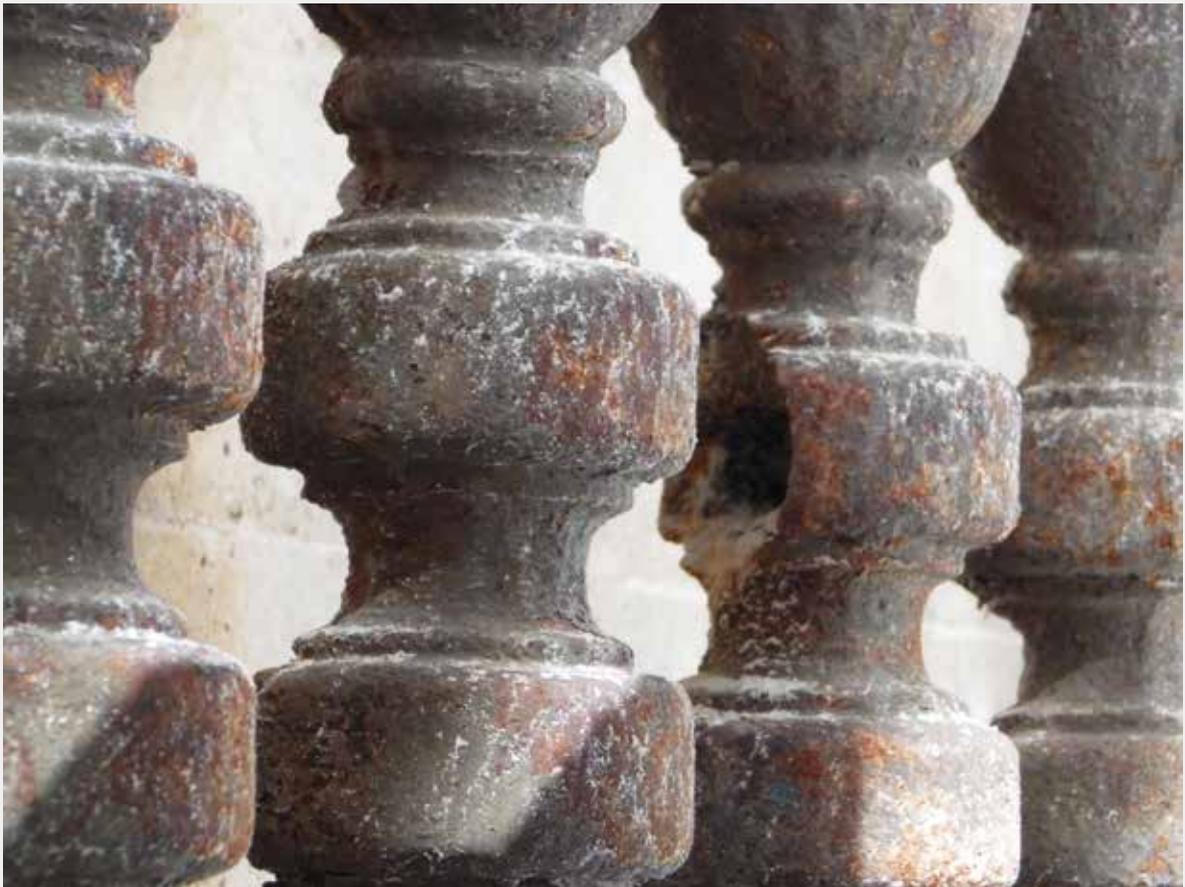
*Le Sac/Den Sack.* Corrosion of metal balusters, leading in some cases to the total degradation of material (© HHU, 2014).

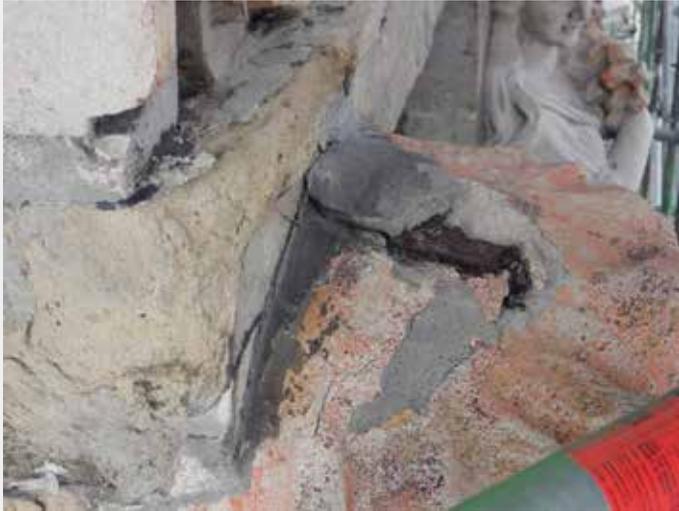
*Le Renard/De Vos.* Corrosion of a metal fixing pin at the top of a statue, causing it to fracture (© HHU, 2014).

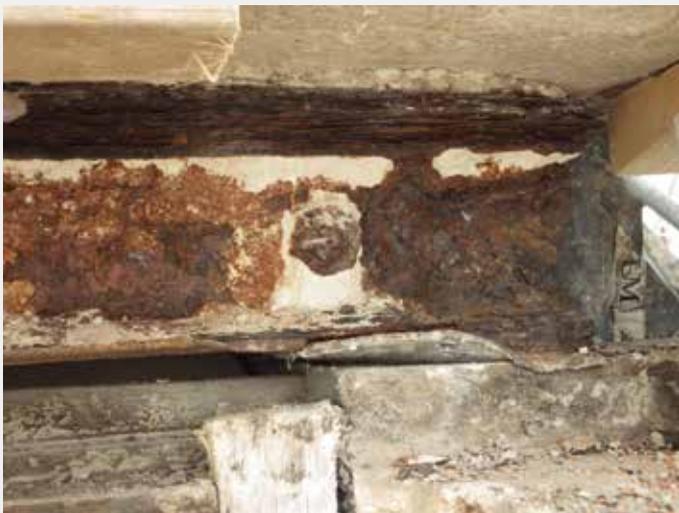
*Le Petit Renard et Le Chêne/Het Vosken en Den Eycke.* Corrosion and development of rust on a metal beam (© HHU, 2014).

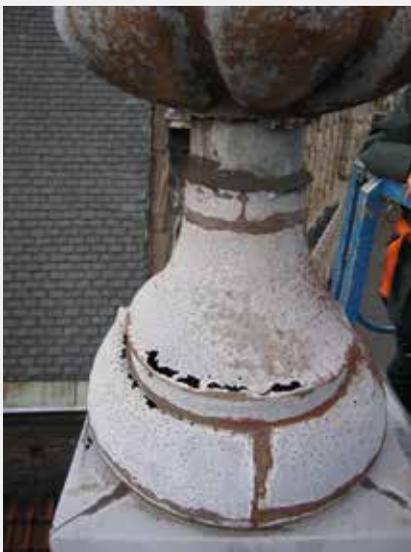
*La Rose/De Roose.* Detail of a corroded and pockmarked zinc vase (© HHU, 2000).

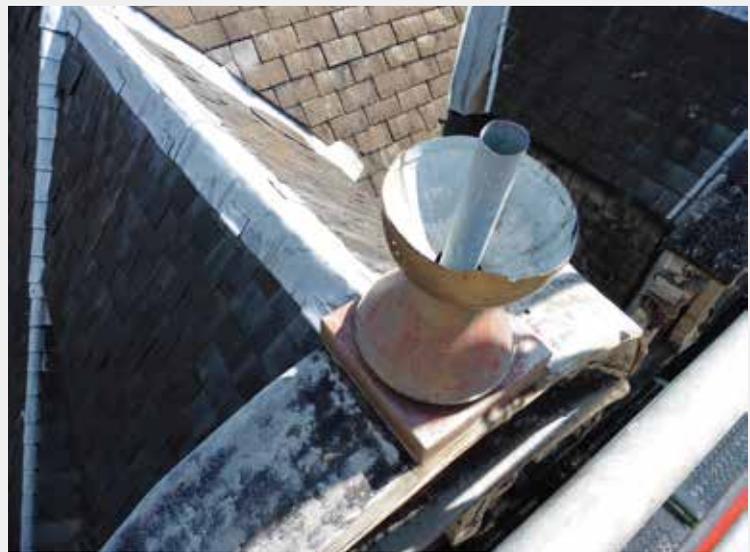
*Le Petit Renard et Le Chêne/Het Vosken en Den Eycke.* A vase split in two as a result of the corrosion of the zinc (© HHU, 2015).

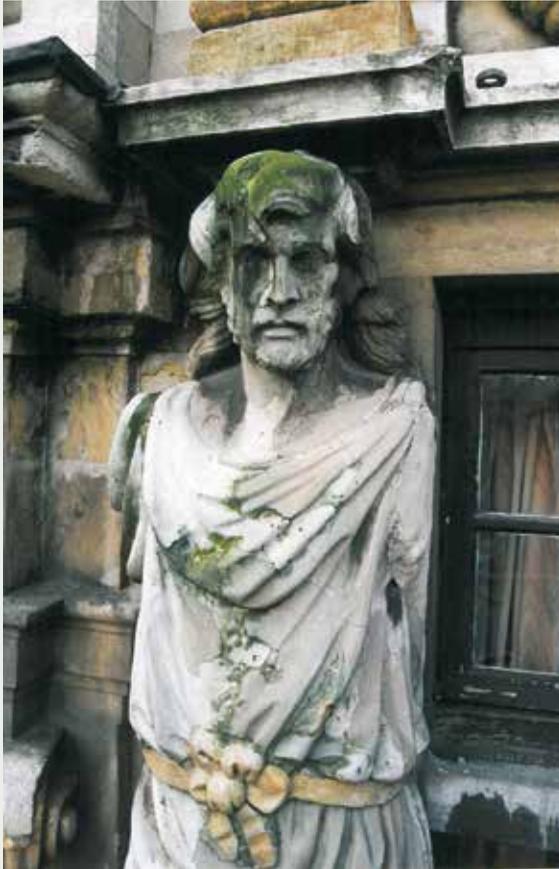
*Le Sac/Den Sack*. One of the terms. Statue covered in moss, with old repairs visible (© HHU, 2000).

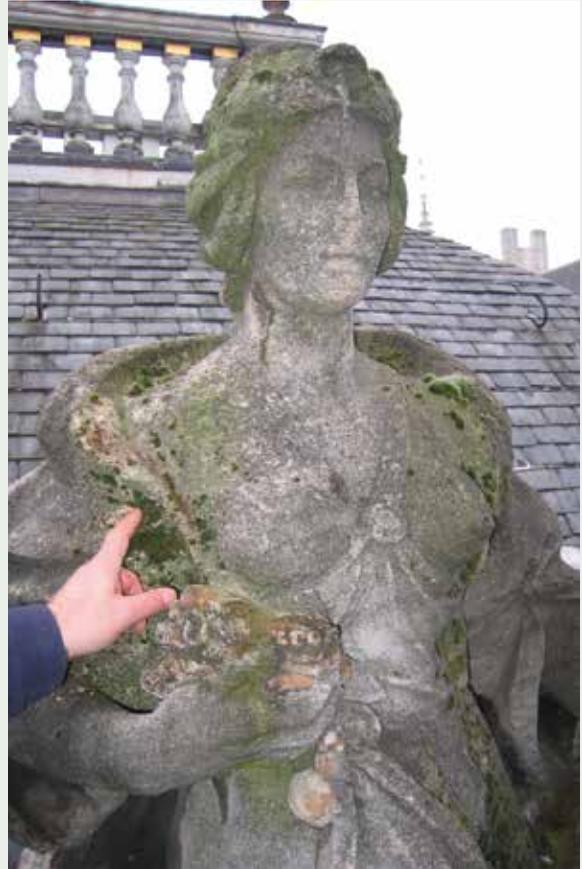
*Le Cygne/De Swane*. Allegory of *L'Abondance/De Onvervloed*. Growth of moss. Euville stone (© HHU, 2000).

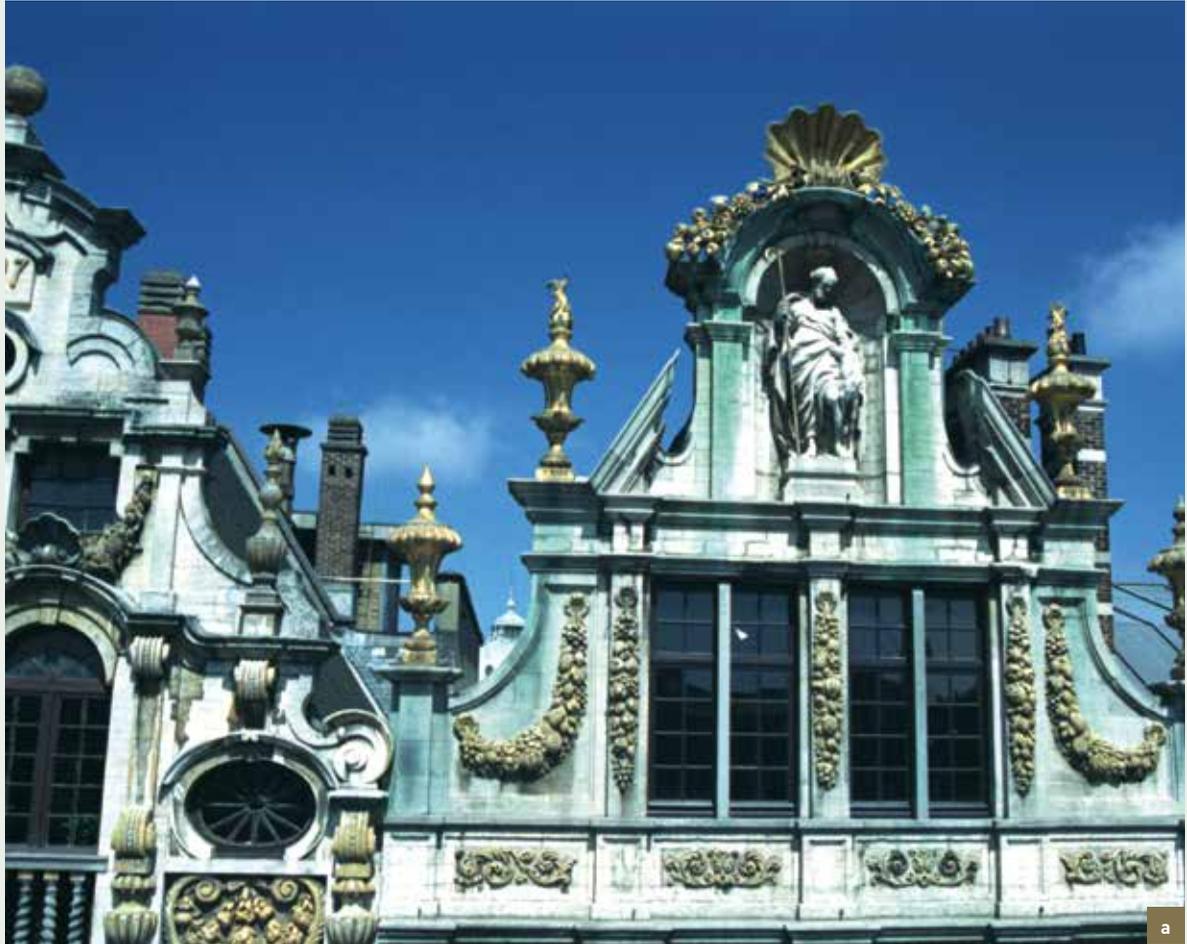
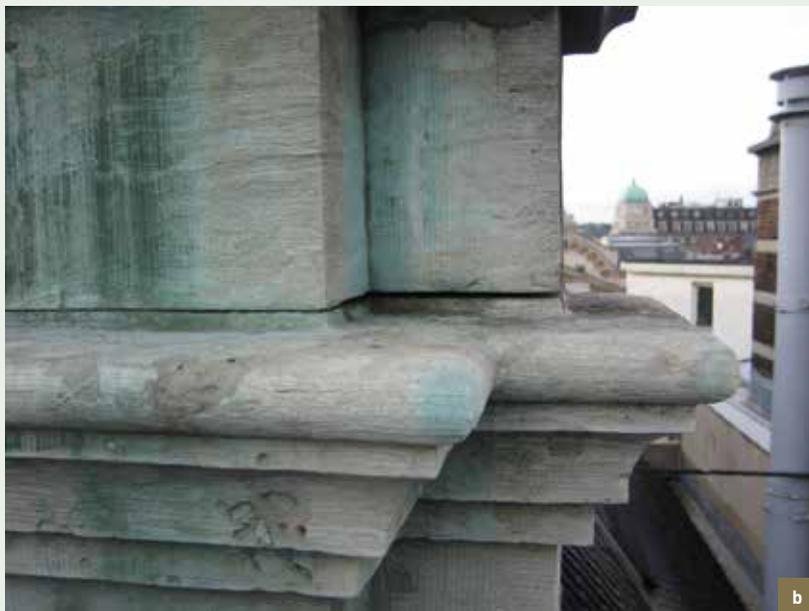
*La Brouette/Den Cruywagen*. Upper section of the façade. Green staining due to the oxidation of copper decorative elements. a) Overview; b) Detail of staining on the Gobertange stone (© HHU, 2014).

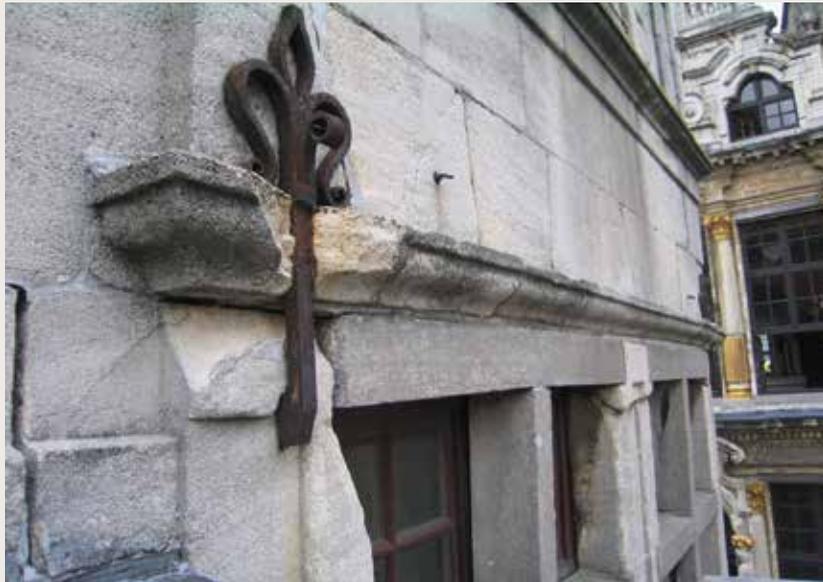
*Le Cerf/De Heert.* Euville stone exhibiting fracture caused by the corrosion of a metal anchor (© HHU, 2000).

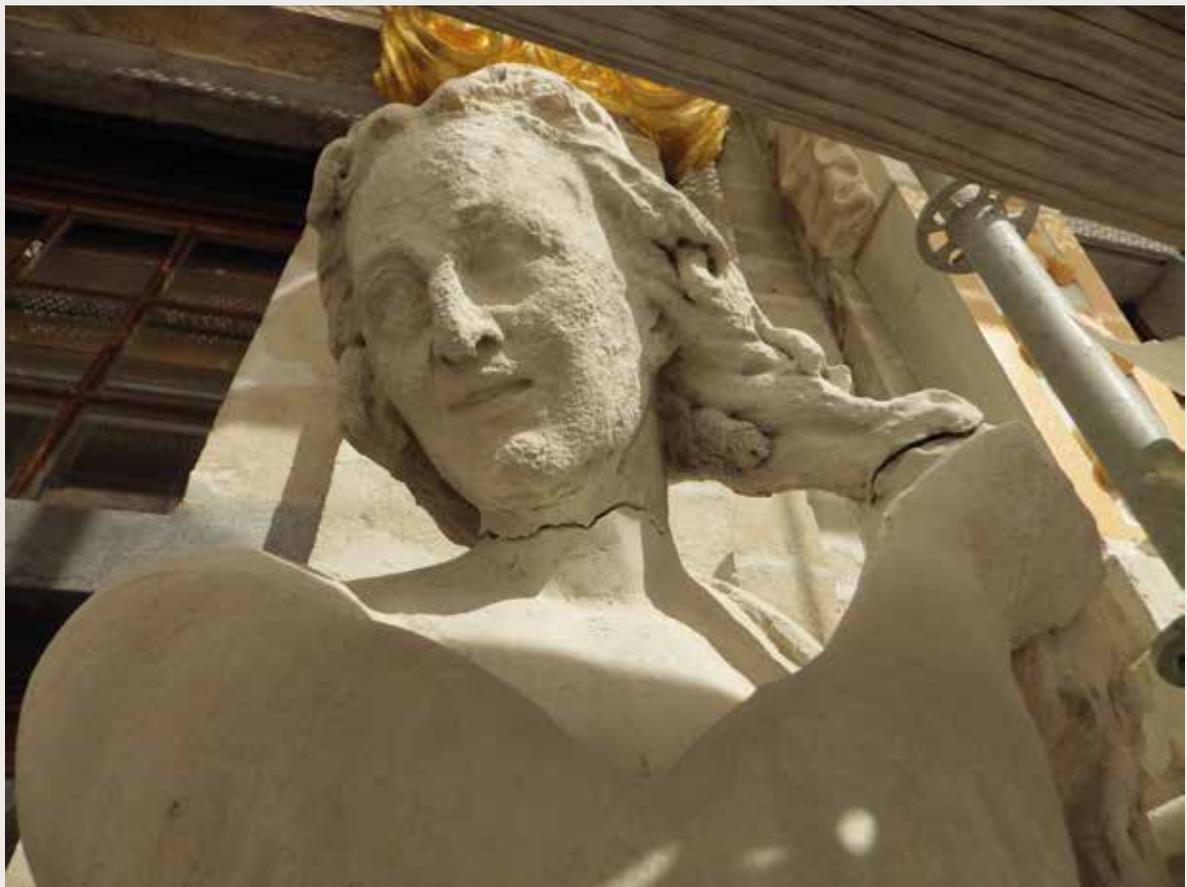
*La Louve/De Wolvin.* Statue with broken head (due to the corrosion of a dowel pin) (© HHU, 2014).

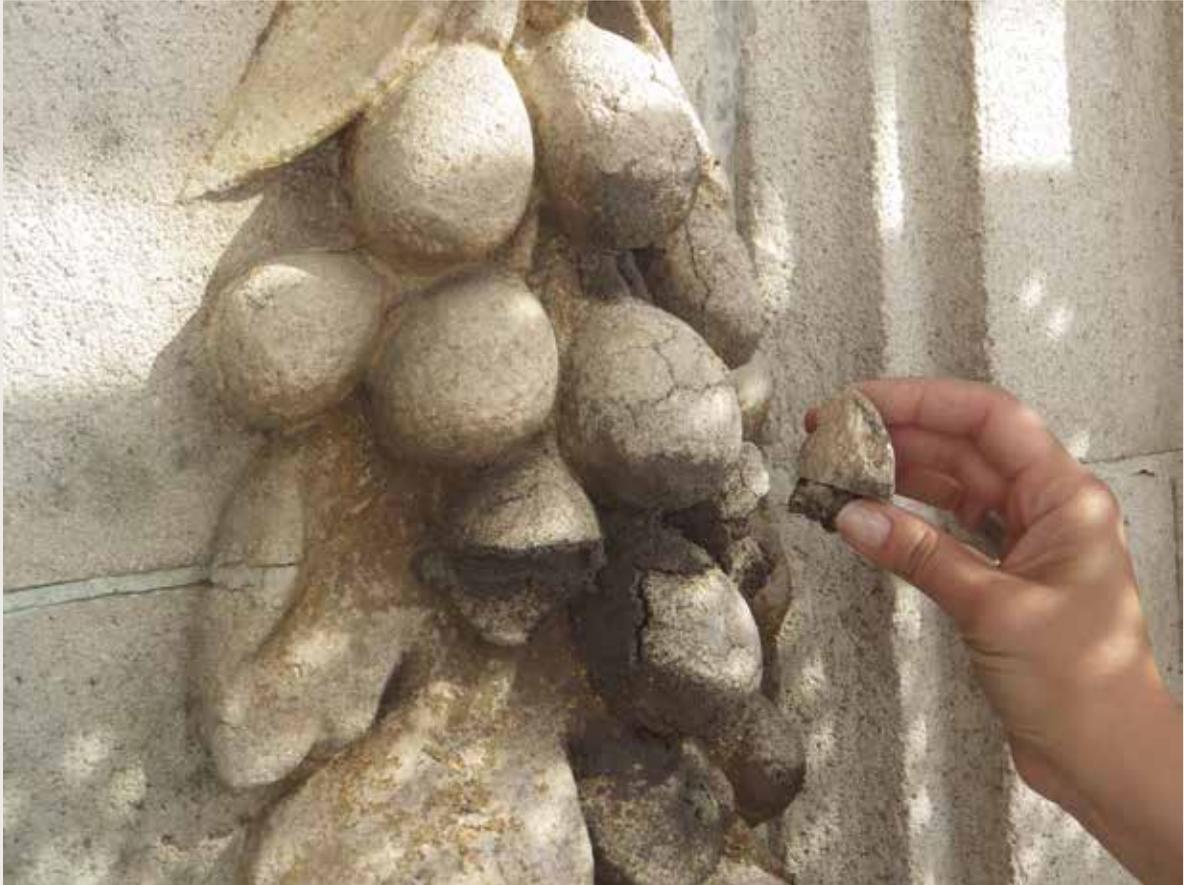
*La Brouette/Den Cruywagen*. Garland of fruit. Broken decorative element. Euville stone (© HHU, 2014).

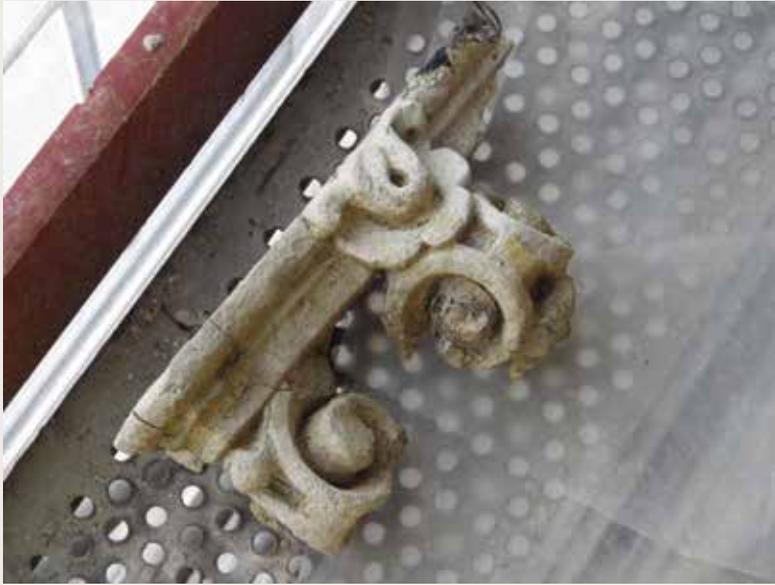
*Le sac/Den Sack*. Broken capital (© HHU, 2014).

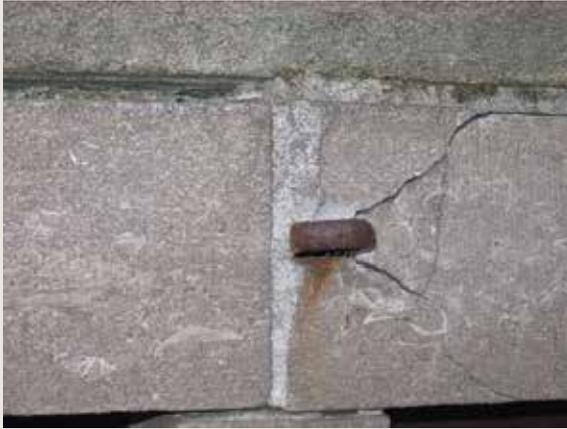
*Le Cerf/De Heert.* Cracks in a blue stone due to the rusting of the metal ring (© HHU, 2000).

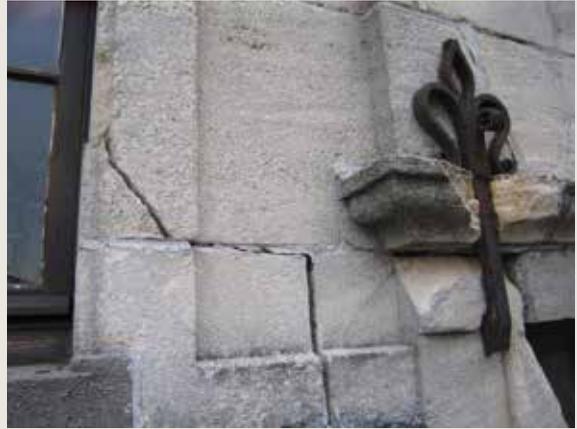
*Joseph et Anne/Joseph en Anna.* Crack in the Euville stone facing (© HHU, 2000).

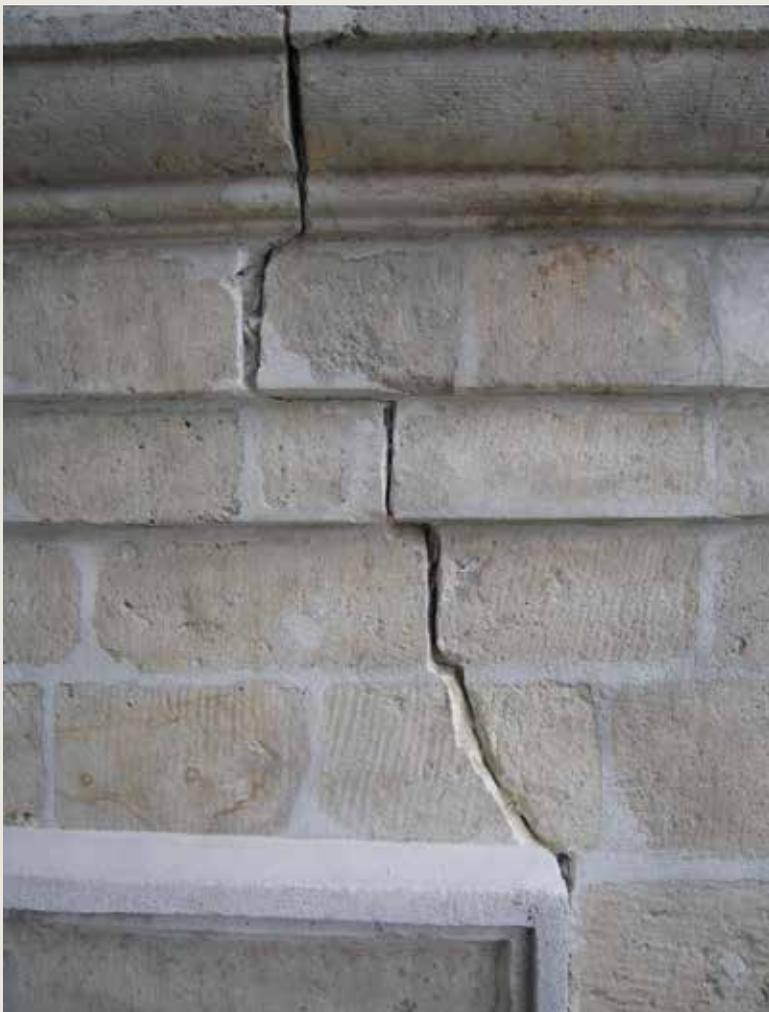
*Le Cygne/De Swane.* Crack in the original Balegem stone facing (© HHU, 2008).

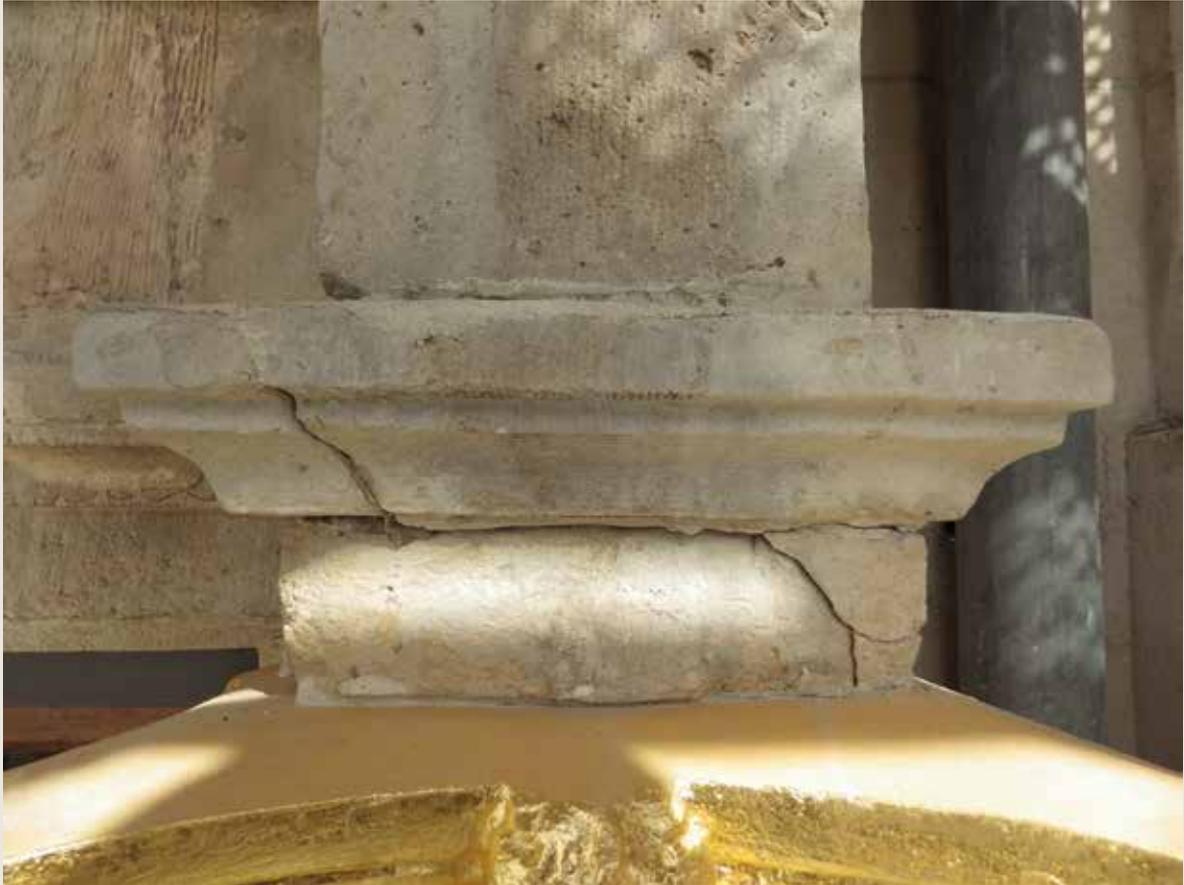
*La Brouette/Den Cruywagen*. Crack in the original Balegem stone facing (© HHU, 2014).

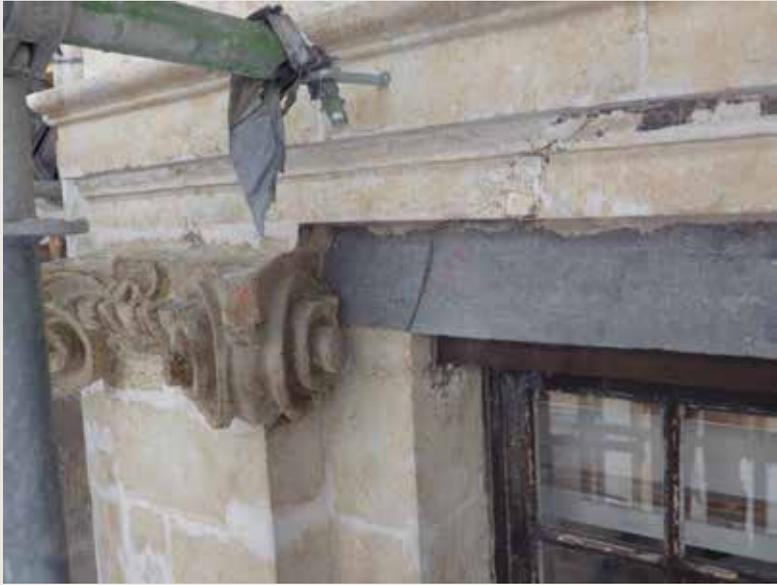
*Le Pigeon/De Duive*. Crack in the blue stone lintel caused by the development of rust on the metal lintel (© HHU, 2012).

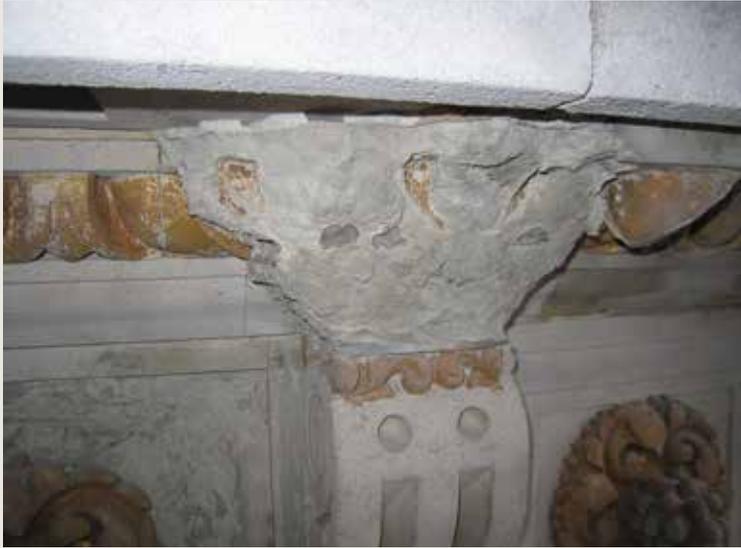
*Le Cygne/De Swane*. Powdering of the console (Avesnes stone?) (© HHU, 2008).

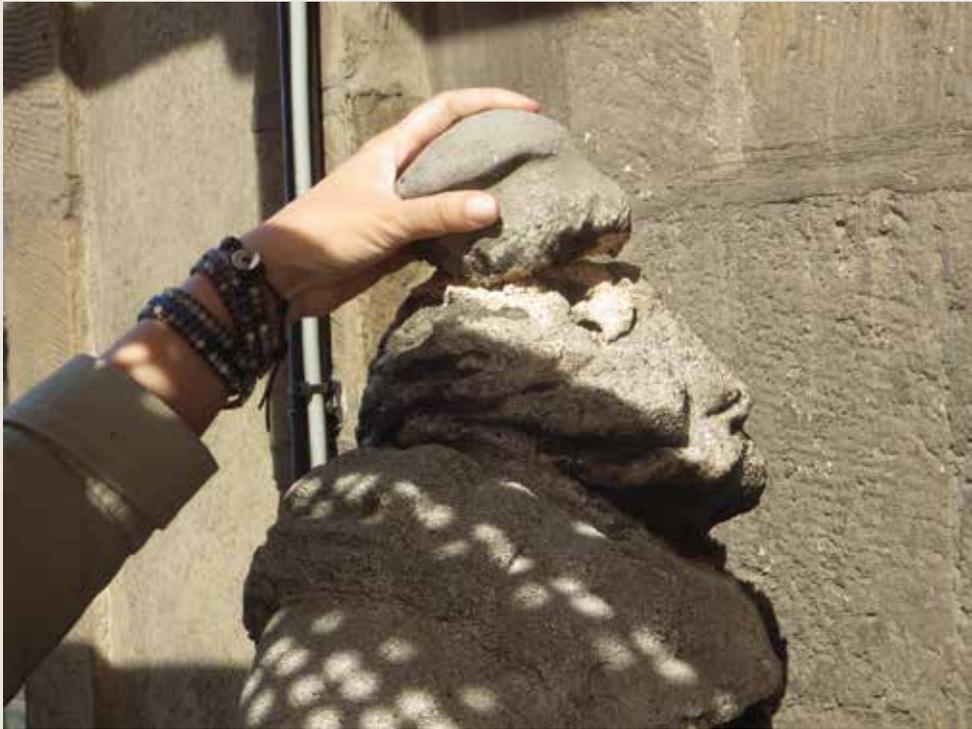
*Le Renard/De Vos.* Powdering of an Euville stone sculpted feature, causing the rupture of an element (© HHU, 2014).

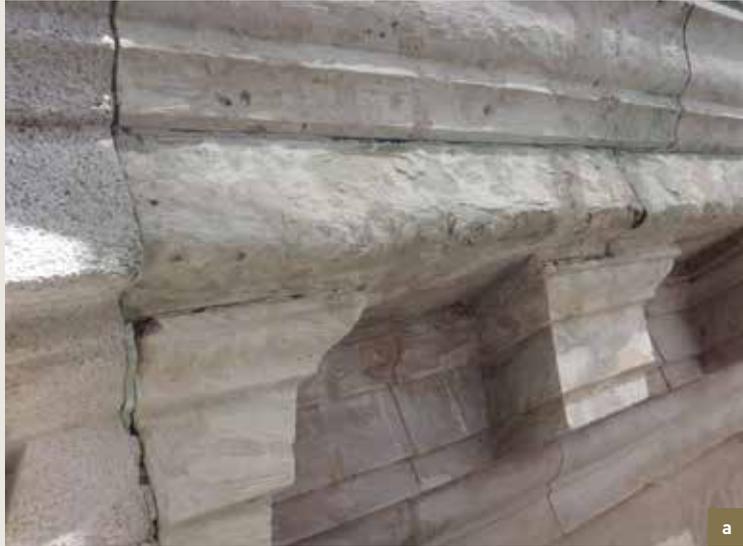
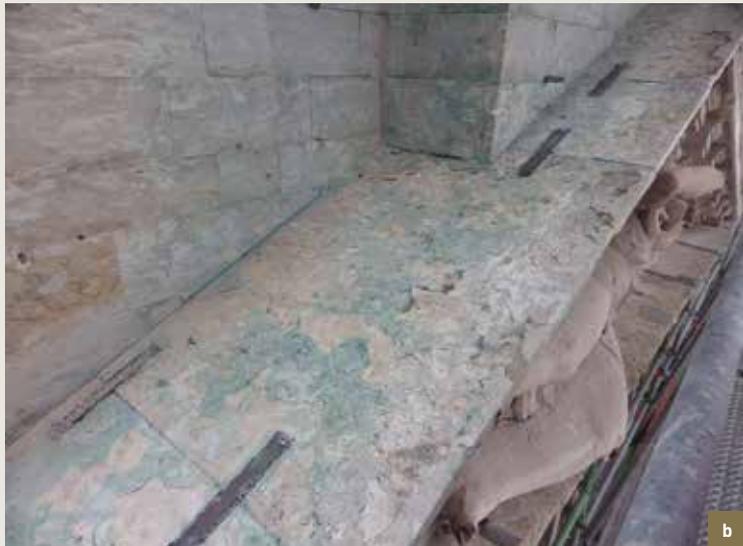
*La Louve/De Wolvin*. Detail of elements on the Gobertange stone pediment. Flaking. a) Front view with appearance of bioturbation on the stone; b) Top view of the pediment with flaking stone visible following the removal of the lead flashing (© HHU, 2014).

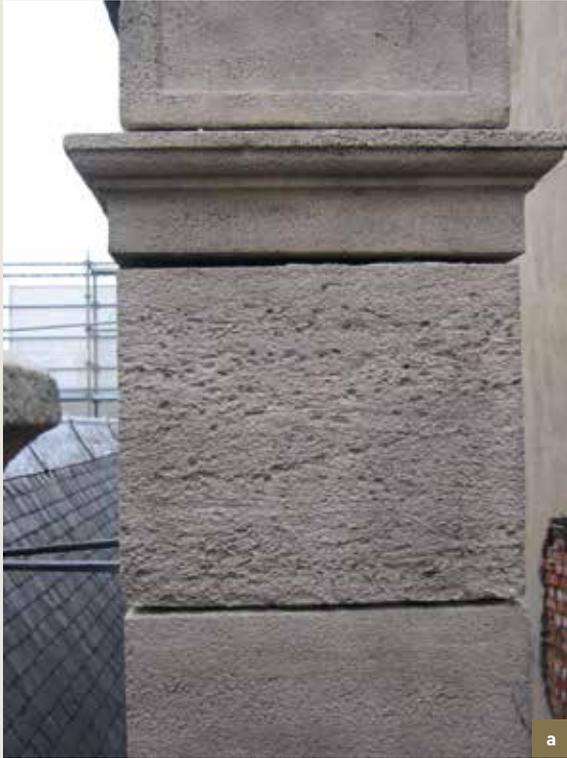
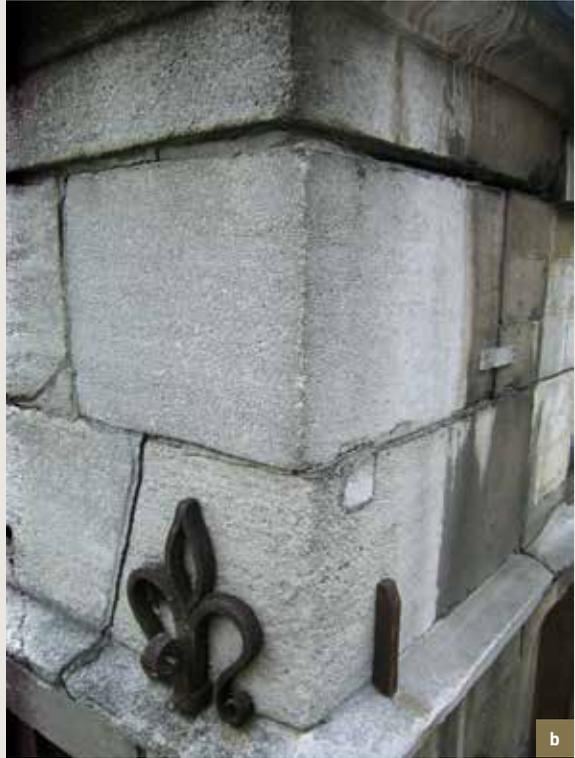
*L'Étoile/De Sterre.* a and b) Separation and open joints in the Euville stone as a result of structural problems (pressure from corroded metal elements in the floor) (© HHU, 2008).

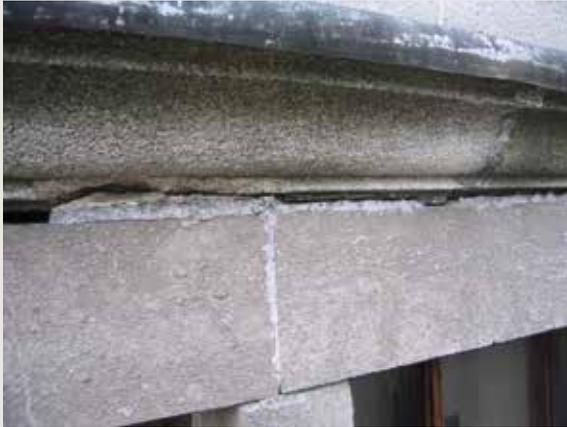
*Joseph et Anne/Joseph en Anna.* Open joint between the blue stone and Euville stone (© HHU, 2008).

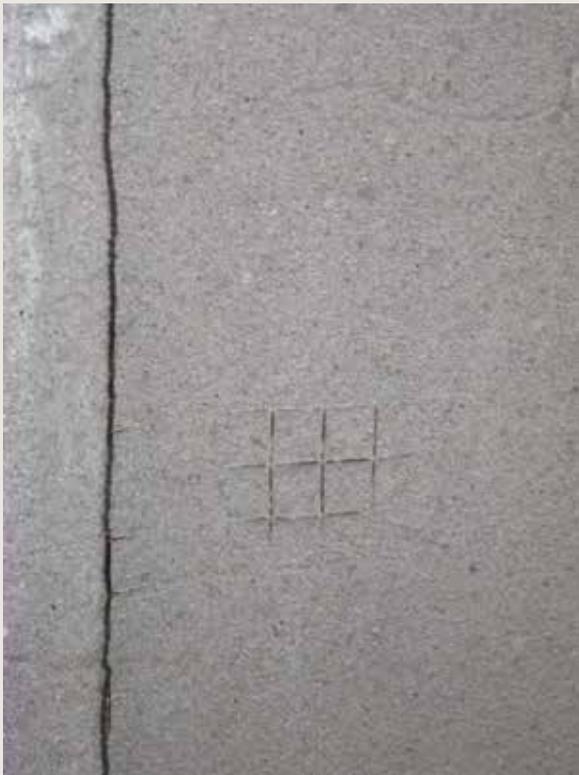
*La Chaloupe d'Or/De Gulden Boot*. Cement render with wire mesh reinforcement appearing on the surface with presence of rust (© HHU, 2008).

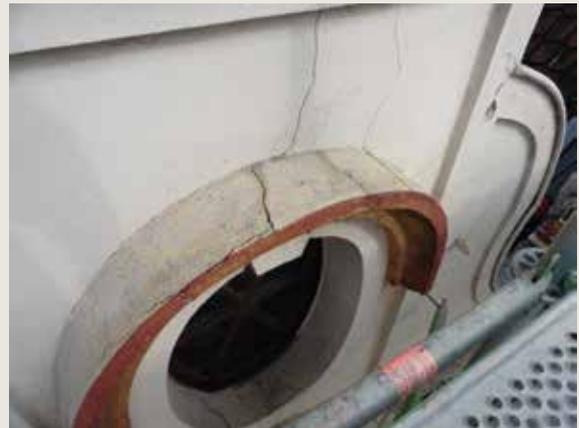
*Le Paon/Den Pauw*. Cracking of the render (© HHU, 2014).

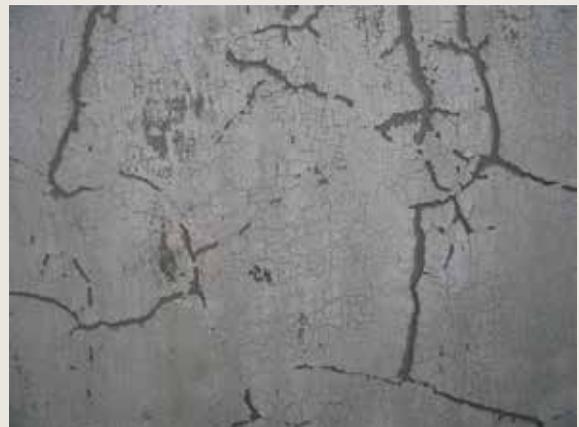
*Le Mont Thabor/Den Bergh Thabor*. Side façade. Cracking of the render and flaking of the paint (© HHU, 2014).

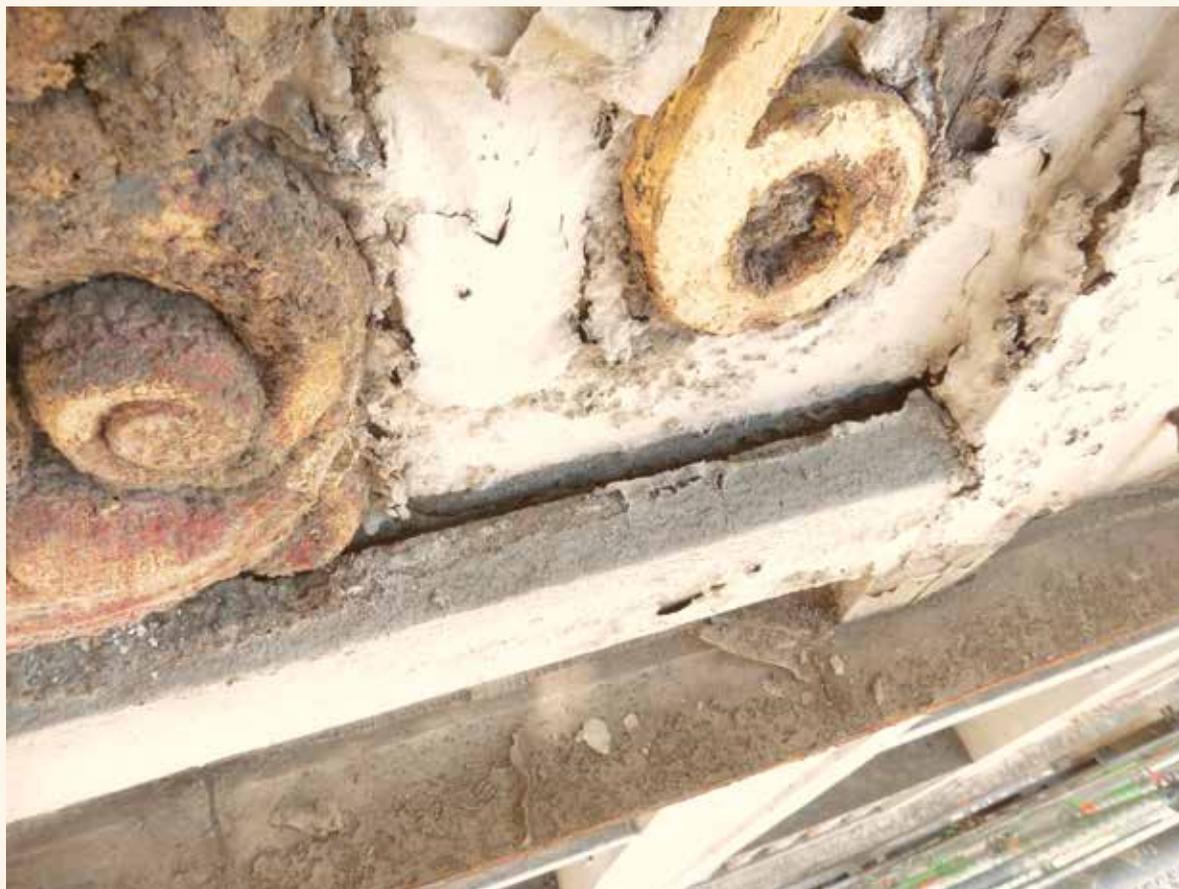
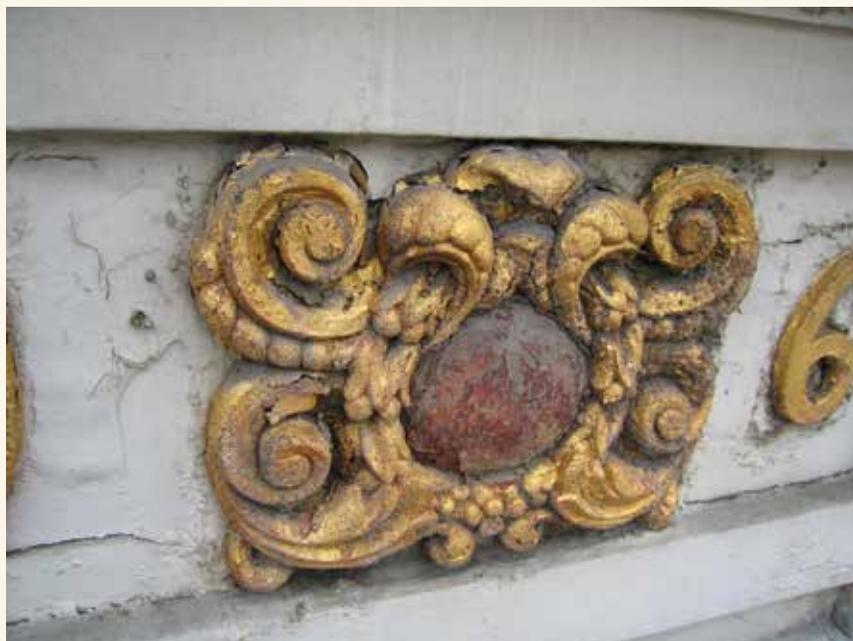
*Le Petit Renard et Le Chêne/Het Vosken en Den Eycke. Medallions with blistering paint, flaking gilding, widespread build-up of dirt (© HHU, 2014).*

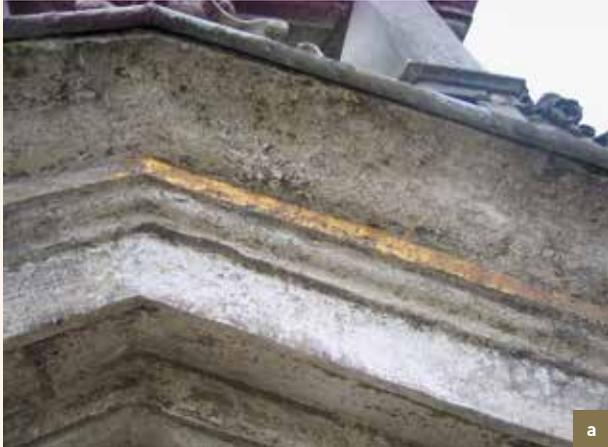
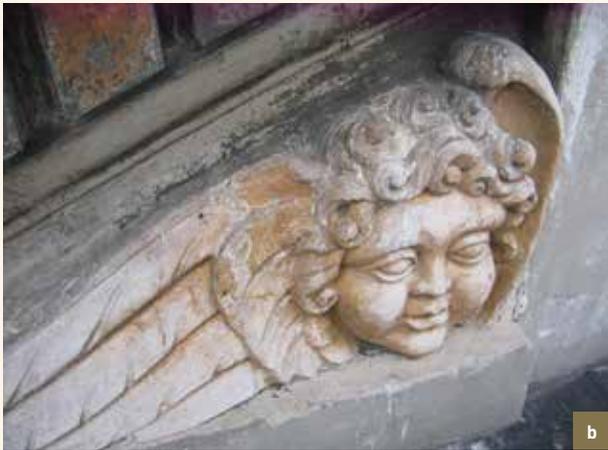
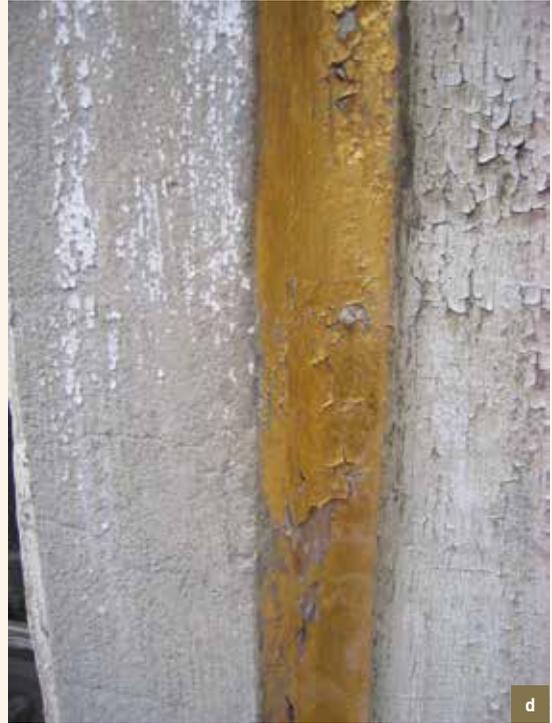
*La Chaloupe d'Or/De Gulden Boot.* a) Detail of pediment. Flaking paint and gilding; b) An angel. Build-up of dirt on paint. Gilding missing; c) Detail of inscriptions on the tympanum. Cracked render. Paint missing. Damaged gilding; d) Detail of pedestal of pilaster with flaking paint and gilding (© HHU, 2012).
