# BRUSSELS HERITAGE

SPECIAL EDITION – 2018

La Grand-Place, Brussels  
inscribed on the World  
Heritage List in 1998

## THE RESTORATION OF AN EXCEPTIONAL DECORATIVE ENVIRONMENT

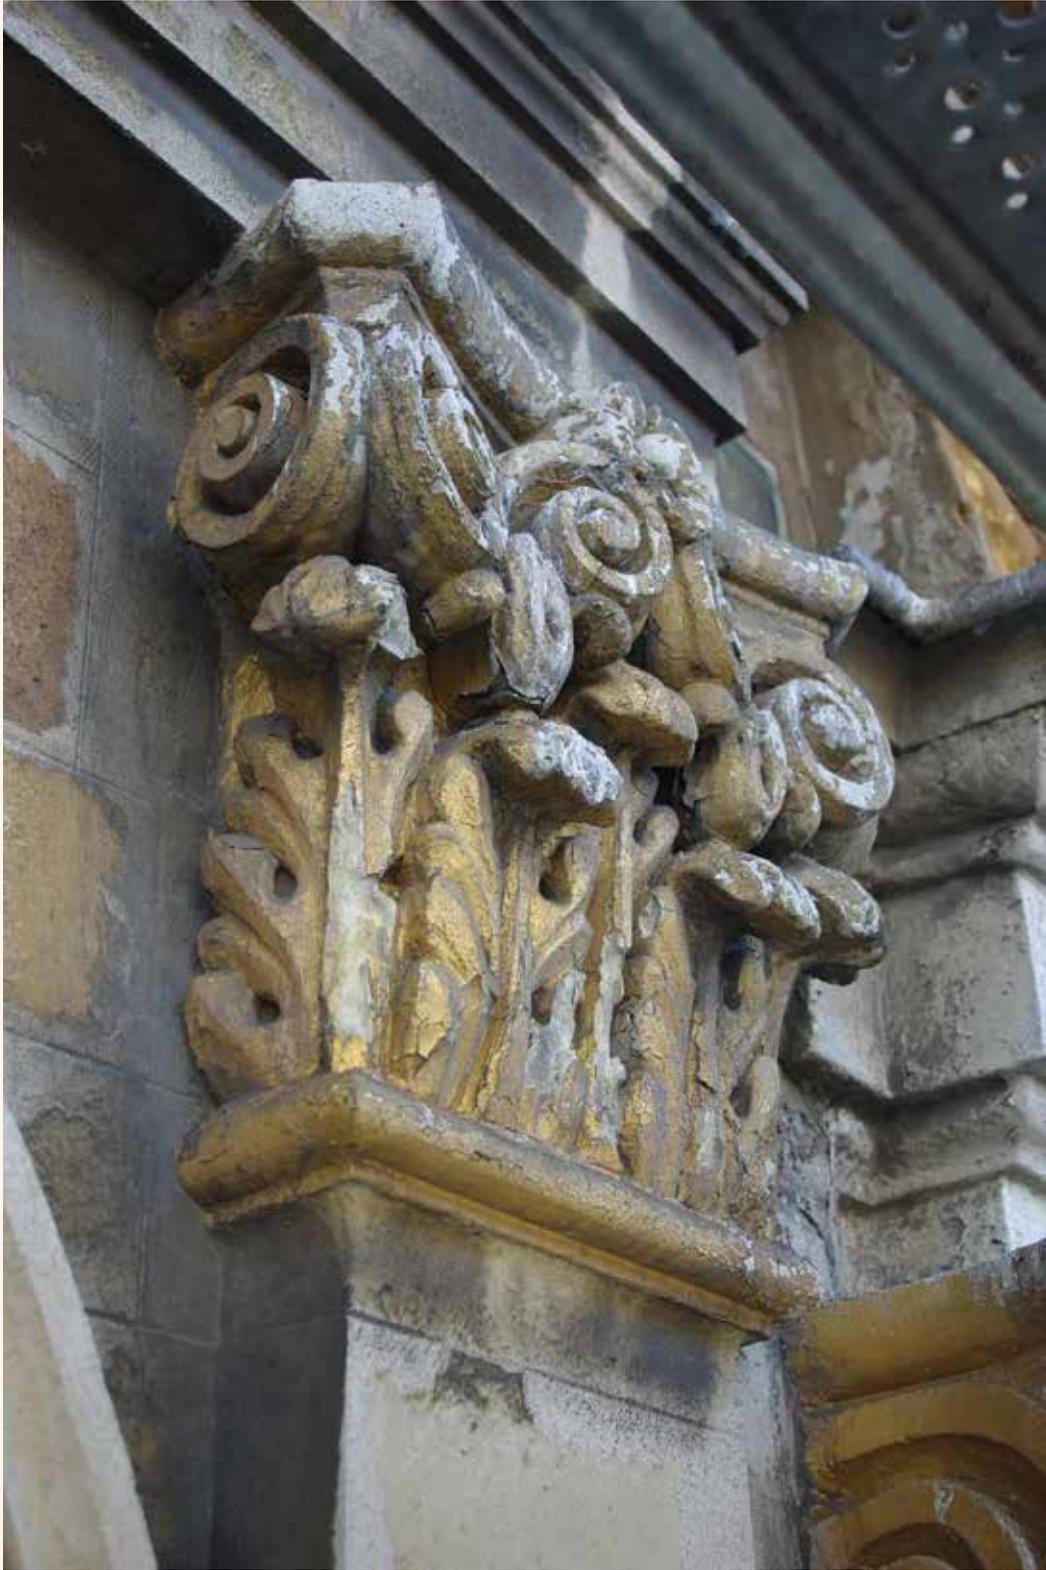
*Le Pigeon/De Duive*. Detail of a composite capital. Chipping of stone leading to damage to the gilding. General wear and tear of the gilding, build up of dirt (© HHU, 2012).

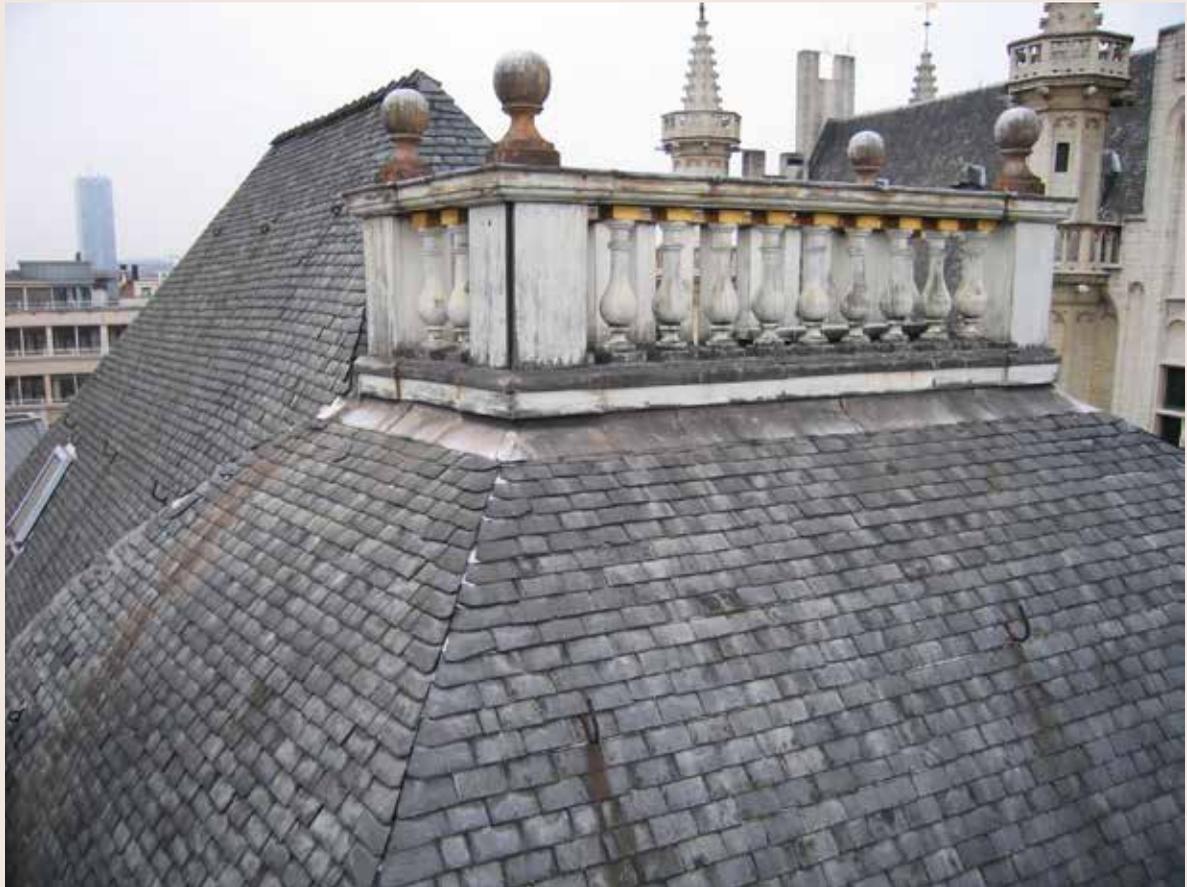
*Le Cygne/De Swane.* Wooden terrace on belvedere. Dislocated elements. Lower sections damaged. Widespread lack of maintenance (© HHU, 2008).

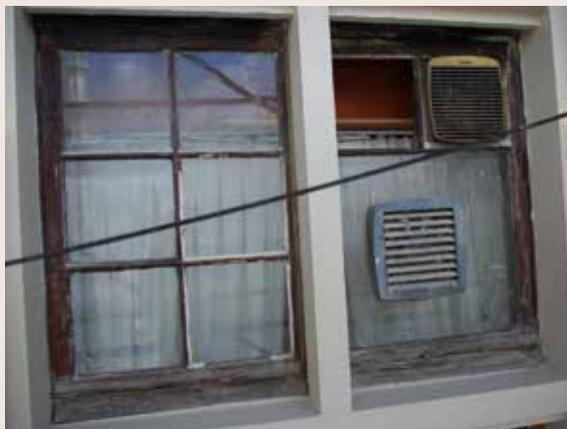
*La Chaloupe d'Or/De Gulden Boot.* Two window frames with damaged weatherboards and window sills. The frames were modified over time to incorporate ventilation outlets in a random fashion (© HHU, 2014).

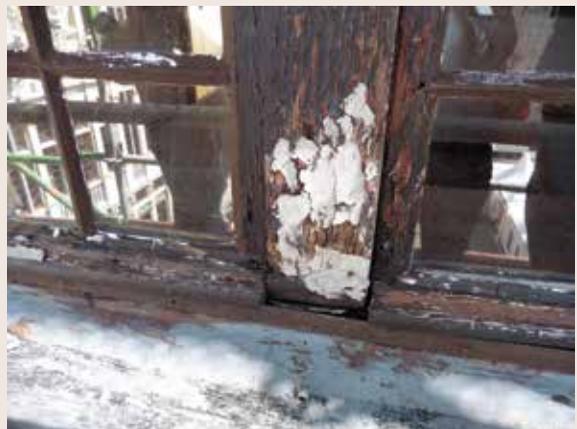
*Le Petit Renard et le Chêne/Het Vosken en Den Eycke.* Badly damaged window frame (© HHU, 2014).

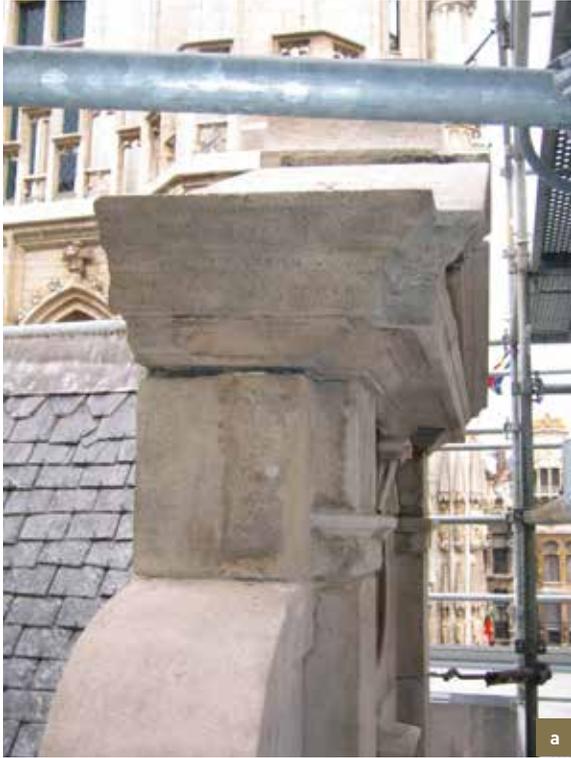
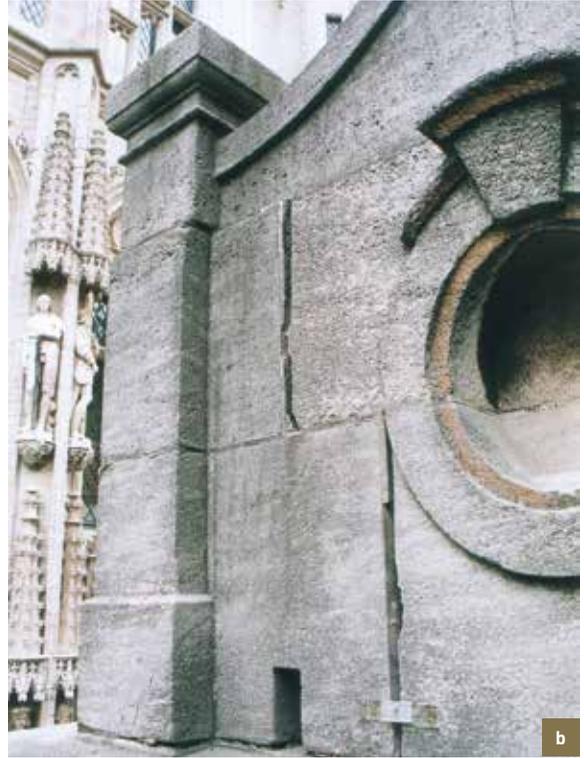
Certain gables were out of plumb by several centimetres. A structural analysis of the buildings, carried out by an engineering firm, confirmed problems with the displacement of the façades due to corroding beams or beam ends, leading to the separation of the stones and

*L'Étoile/De Sterre*. Structural problems. a) Tilting of gable pediment on the façade facing the Grand Place. Euville stone; b) Separation of stones in the rear façade. Crack meter installed during the schedule of condition (© HHU, 2008).

even fracturing. The data from the crack meters installed during the inspections in 2000 showed that the gables had stabilised in the meantime. Nevertheless, the damage caused by the spreading of the rust to the surrounding stones made the dismantling of the gables in each instance necessary, as well as the total replacement of the corroded metal beams responsible for the

problems. This was the case with *L'Âne/Den Ezel*, *La Brouette/Den Cruywagen*, *L'Étoile/De Sterre* and *La Chaloupe d'Or/De Gulden Boot*. On the lower floors, I-beams or square bars also exhibited signs of corrosion requiring them to be replaced, as with *Le Cerf/ De Heert*, *Le Paon/ Den Pauw*, *Sainte-Barbe/Sint Barbara* and *Le Roi d'Espagne/Den Coninck van Spaignien*.

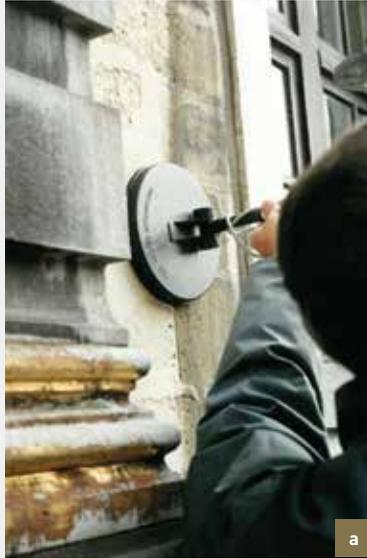
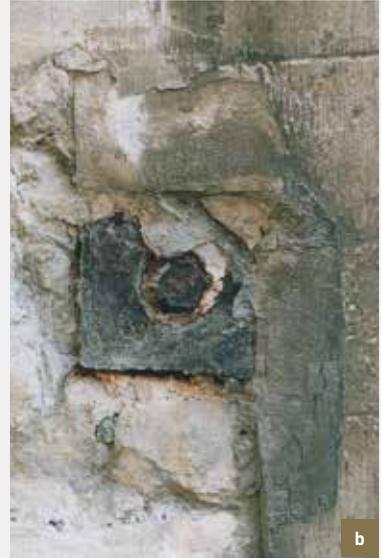
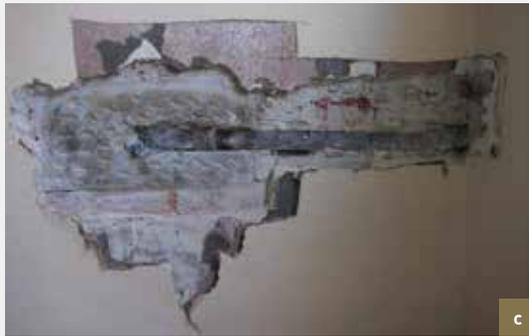
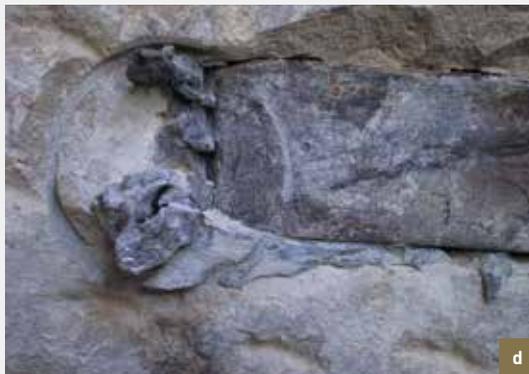
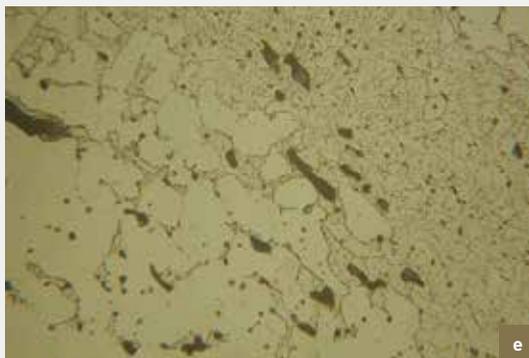
Next, targeted surveys revealed their exact shape: one wrought iron tip is anchored in lead within a large block of white stone inserted in the brick party wall. At the other end, the rectangular metal plate is rounded with screw threads, which enable the load distribution plate to be attached by means of a bolt. A metallographic analysis helped to determine the composition of the iron, which is relatively pure, some of its properties, such as its hardness, the presence of inclusions and impurities, and even to identify the corrosion products. The anchors were also analysed, revealing lead of a high degree of purity. Additional analyses on the square bars were also carried out on the façade.

*L'Âne/Den Ezel*. Metal anchor. a) Locating anchors by means of a metal detector; b) Square plate visible on the façade behind the crumbling facing; c) Stripping of interior plaster in order to see the shape of the anchor; d) Detail of lead anchor in the stone; e) Metallographic study. Micrograph image (a, b, c en d) : © HHU, 2001; e) : © VUB, 2001).
