# BRUSSELS HERITAGE

SPECIAL EDITION – 2018

La Grand-Place, Brussels  
inscribed on the World  
Heritage List in 1998

## THE RESTORATION OF AN EXCEPTIONAL DECORATIVE ENVIRONMENT

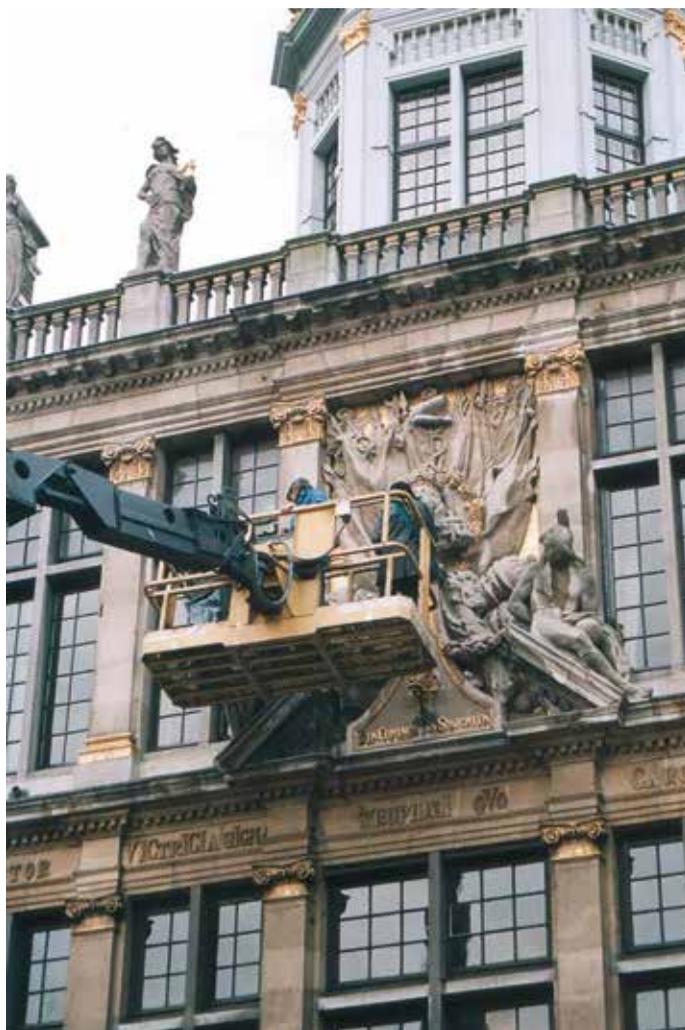
*Le Sac/Den Sack.* Detail of a sculpted term before restoration.  
Badly damaged due to old repairs (© HHU, 2000).

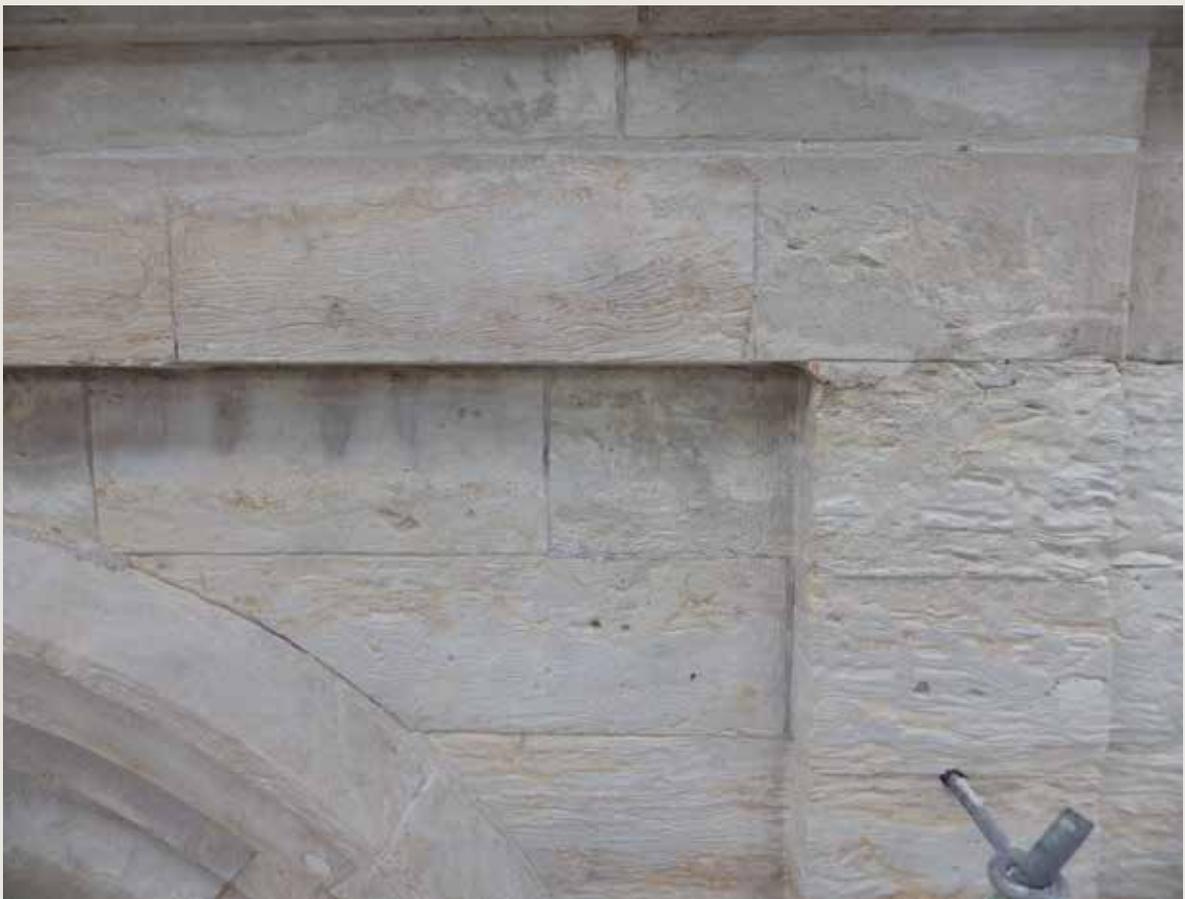
*Le Heaume/Den Helm*. Detail of bioturbation in Gobertange stone (© HHU, 2014).

The original Balegem stone (Ledian sandstone), the surface of which is wearing away, is now difficult to identify due to the layer of cement (repair work) with which it was extensively covered. The Gobertange stone facing has been badly damaged by atmospheric pollution. The surface has become dulled and rough due to the dissolving of softer areas. This has revealed the regular layers of bioturbation in the stone, that is to say the disturbance of sediments by the activity of living organisms forming little tunnels.

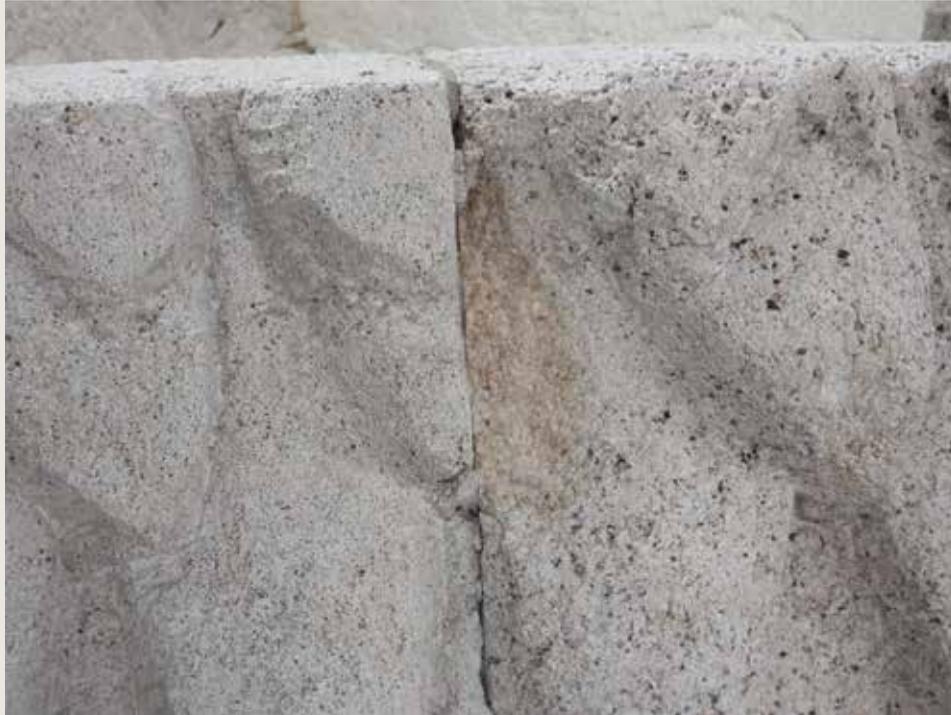
*Le Cornet/Den Horen.*  
Chipped element  
made from Euville  
stone (© HHU, 2014).

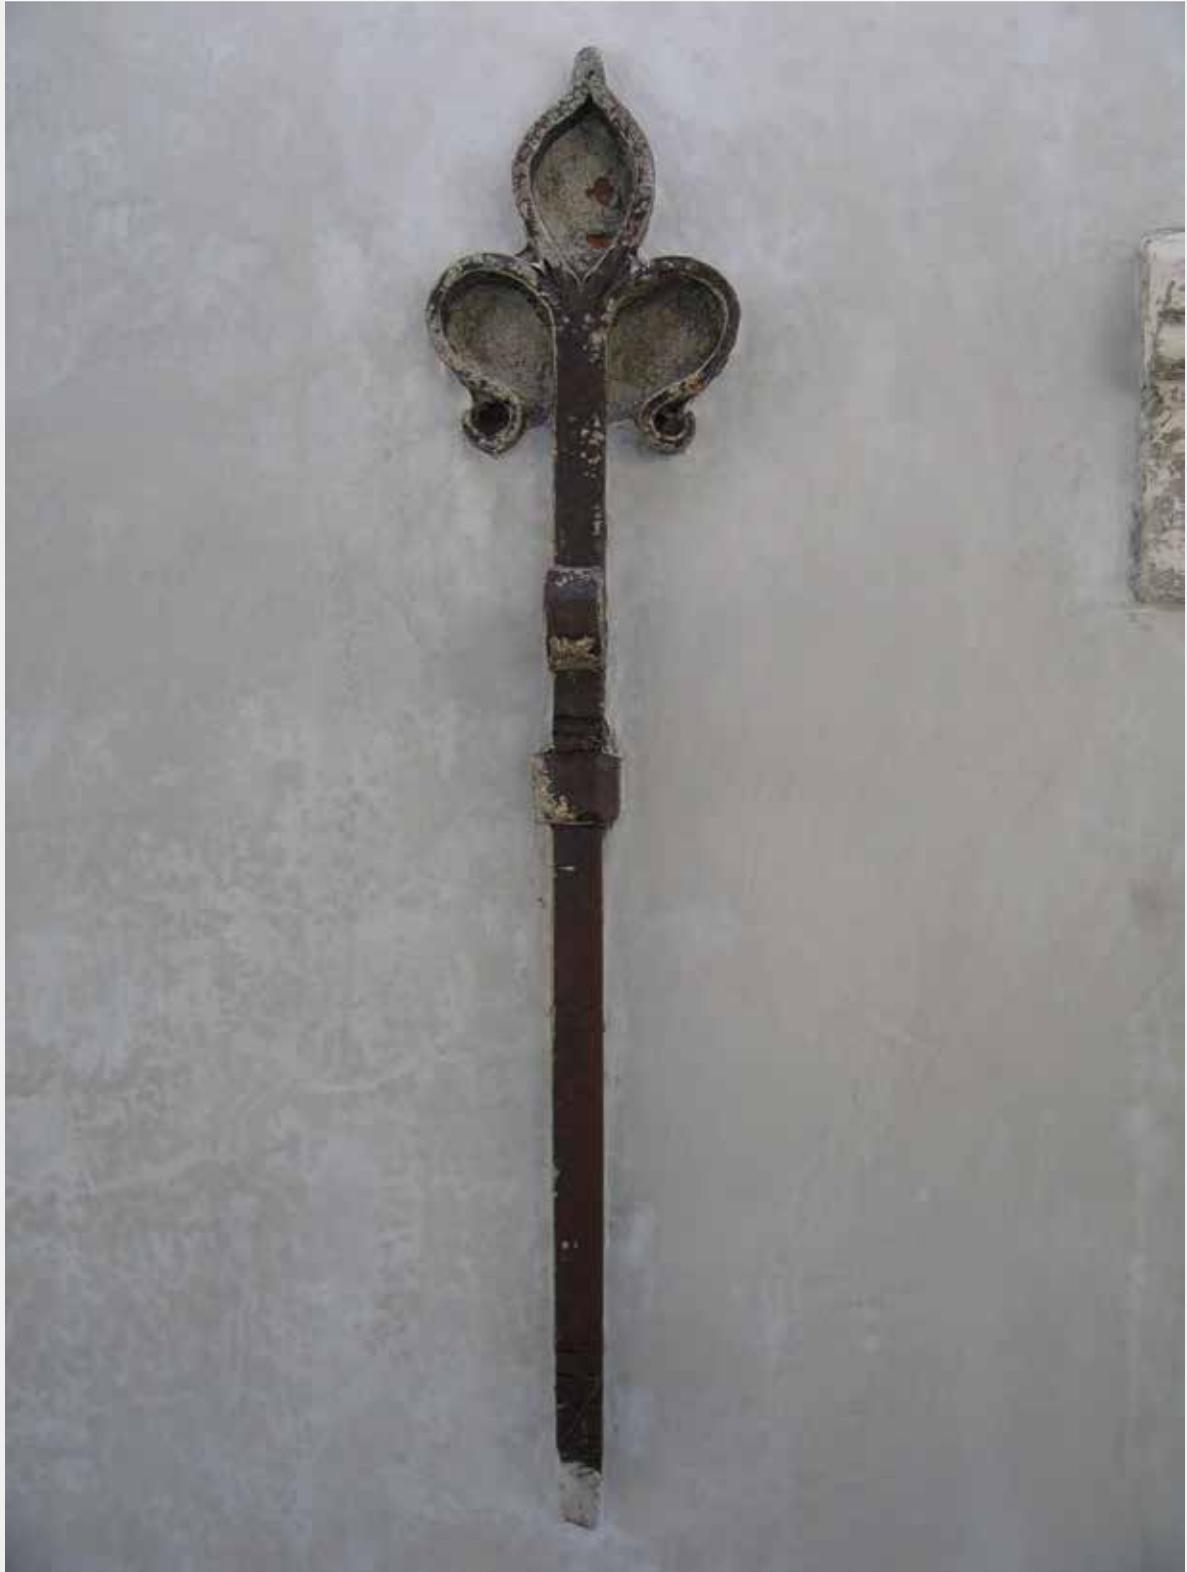
*Le Mont Thabor/Den Bergh Thabor. Rendered side façade. Metal anchor (© HHU, 2008).*

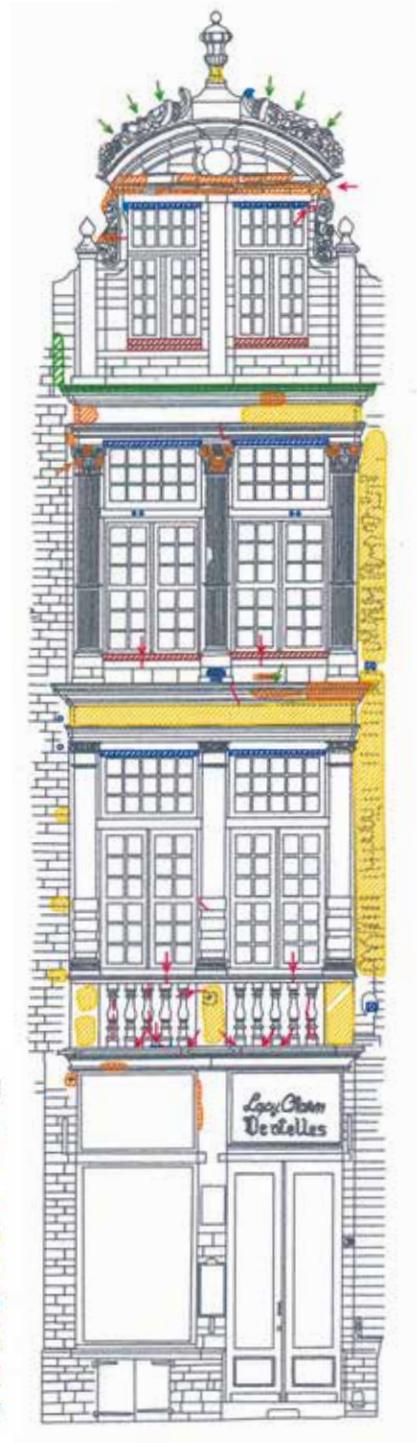
L'Âne/Den Ezel. Sketching of façades with survey of pathologies. This survey was supplemented with photographs and descriptions of each damaged element (© HHU, 2000).

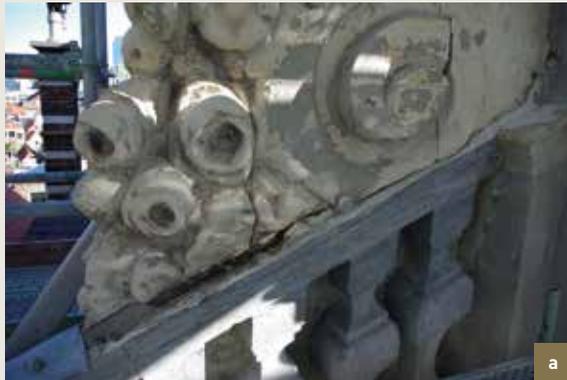
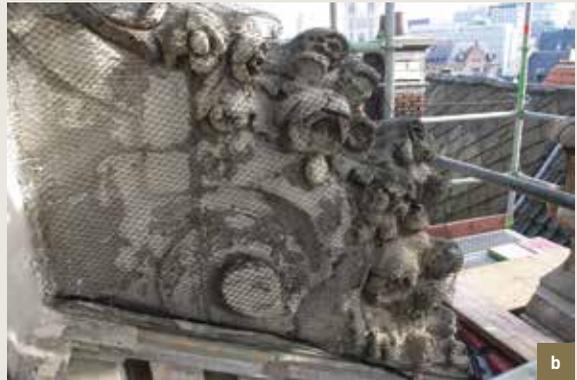
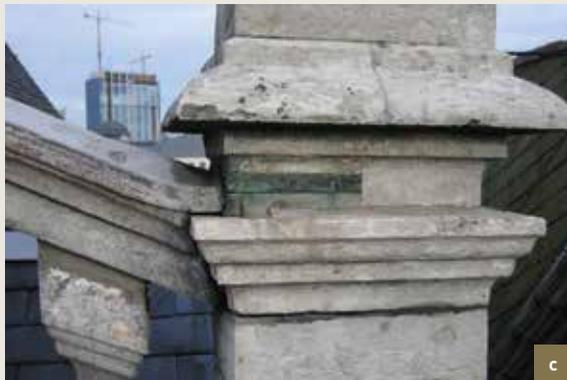
*La Chaloupe d'Or/De Gulden Boot.* a) Left side aileron with flower motifs. The element is becoming detached and sliding outwards as a result of a corroding metal pin; b) Idem. Right section. Installation of temporary protective net following the inspection, while awaiting the restoration work; c) Displacement of right pinnacle of gable; d) Idem on left side. Beneath the lead, rust can be seen on the metal pin causing the aforementioned problems (© HHU, 2000).

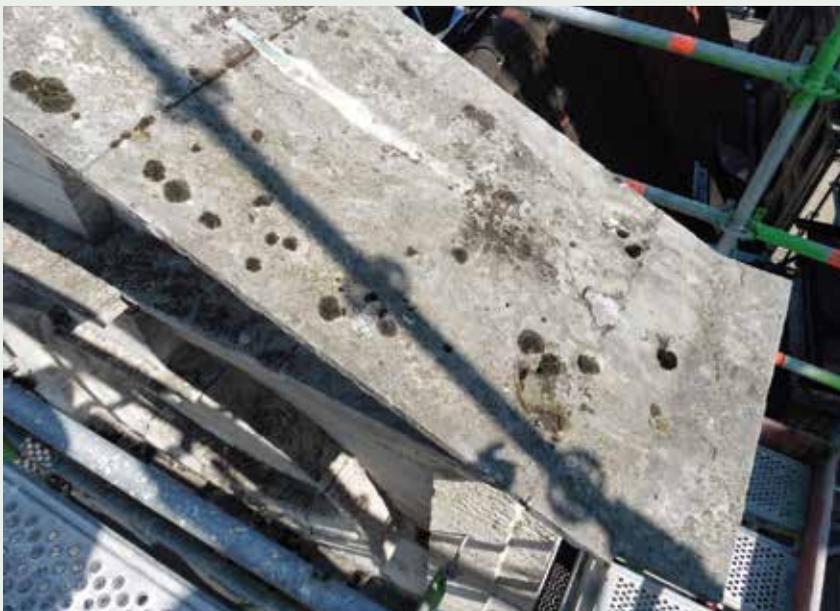
*Le Heaume/Den Helm*. Growth of moss on the slope of the pediment. Gobertange stone (© HHU, 2015).

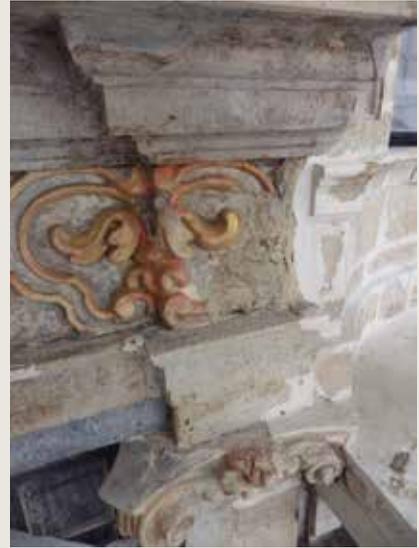
*Le Renard/De Vos*. Powdering of an original frieze (Avesnes stone?) (© HHU, 2012).

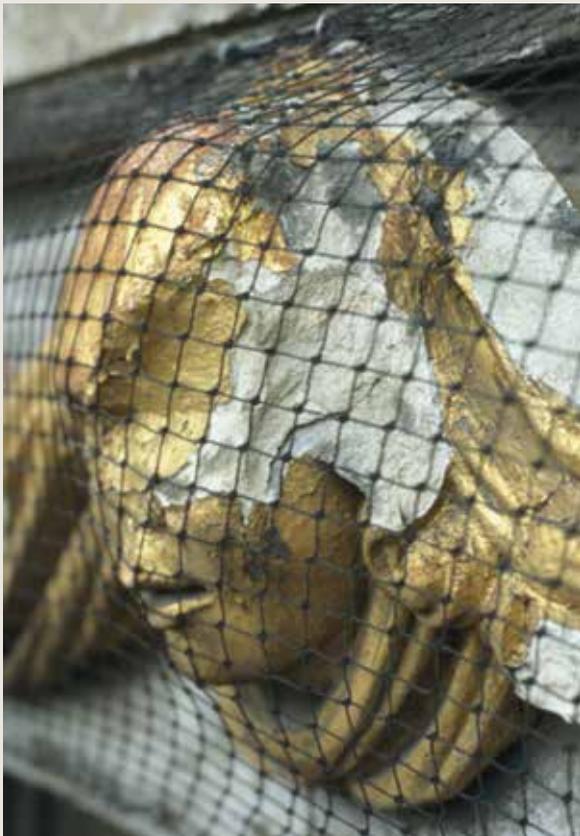
*La Rose/De Roose*. Powdery sculpted element (Avesnes stone?). It has been temporarily covered with a net to prevent it from falling (© HHU, 2000).

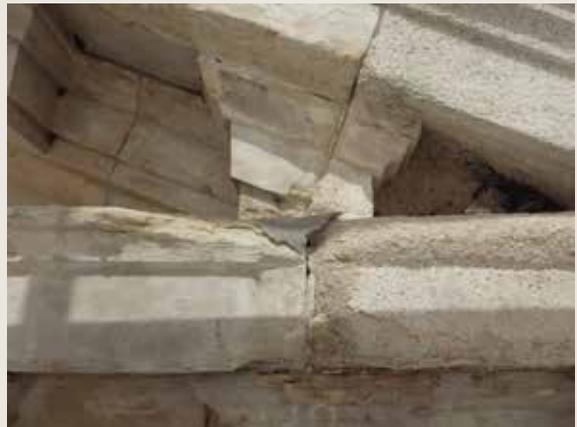
*La Louve/De Wolvin*. Powdery elements on the Euville stone on the right and Gobertange stone on the left (© HHU, 2014).

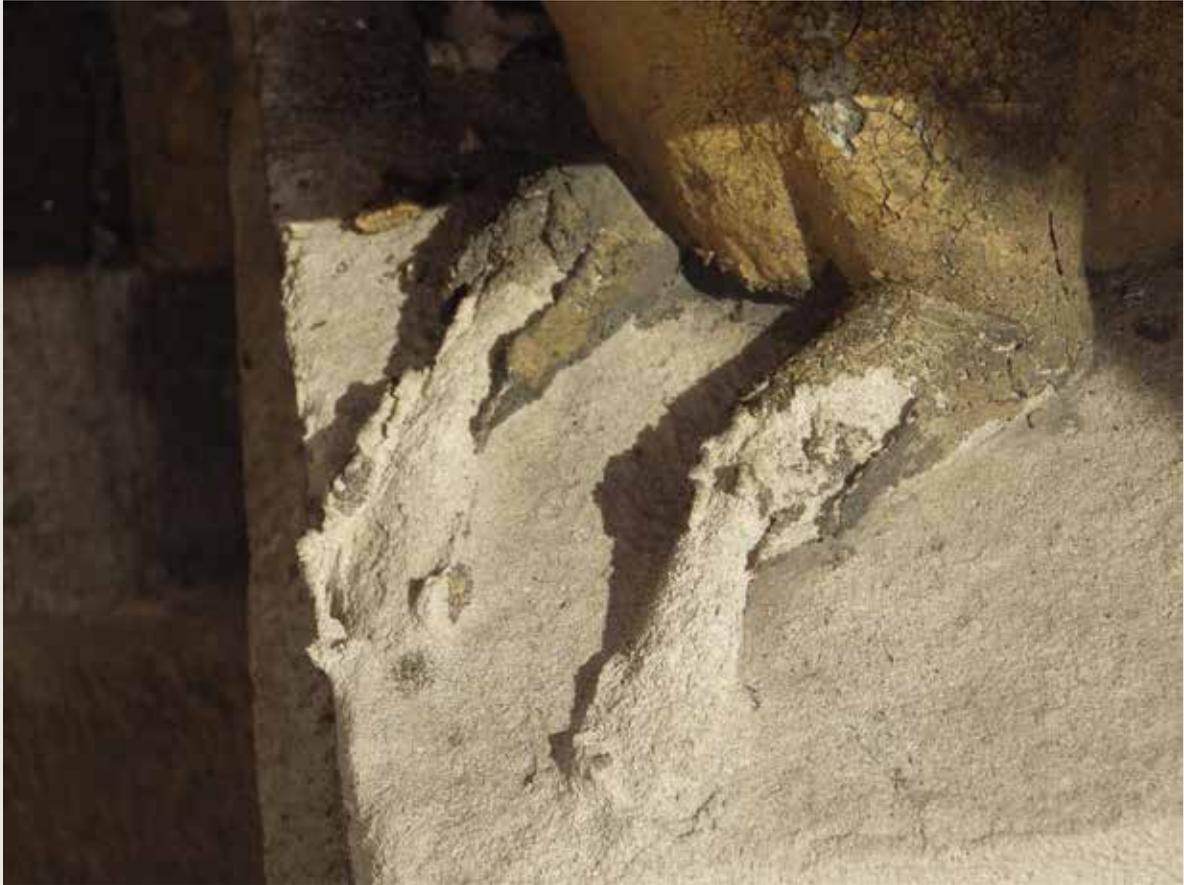
*La Louve/De Wolvin.* Powdering of Euville stone on a sculpted element (© HHU, 2014).

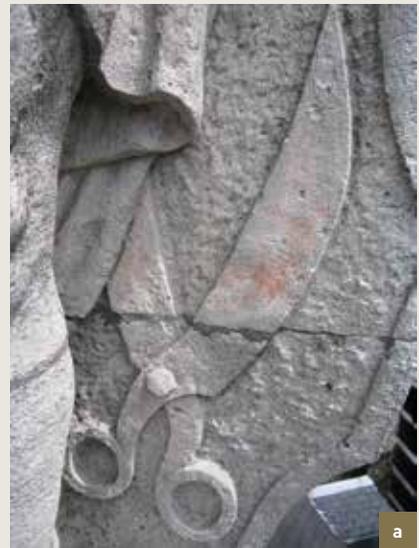
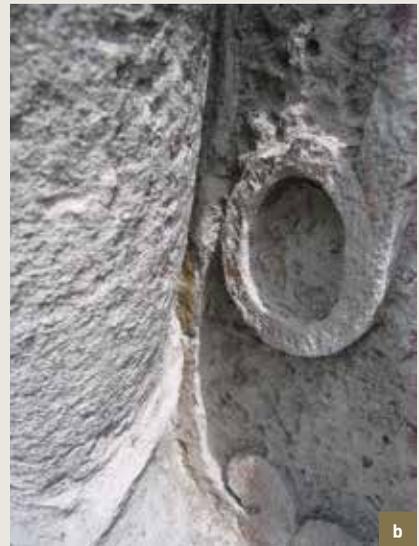
*La Chaloupe d'Or/De Gulden Boot*. Details of the statue of Saint Boniface. a) Honeycomb weathering on the scissor-shaped element. Euville stone; b) Detail (© HHU, 2012).

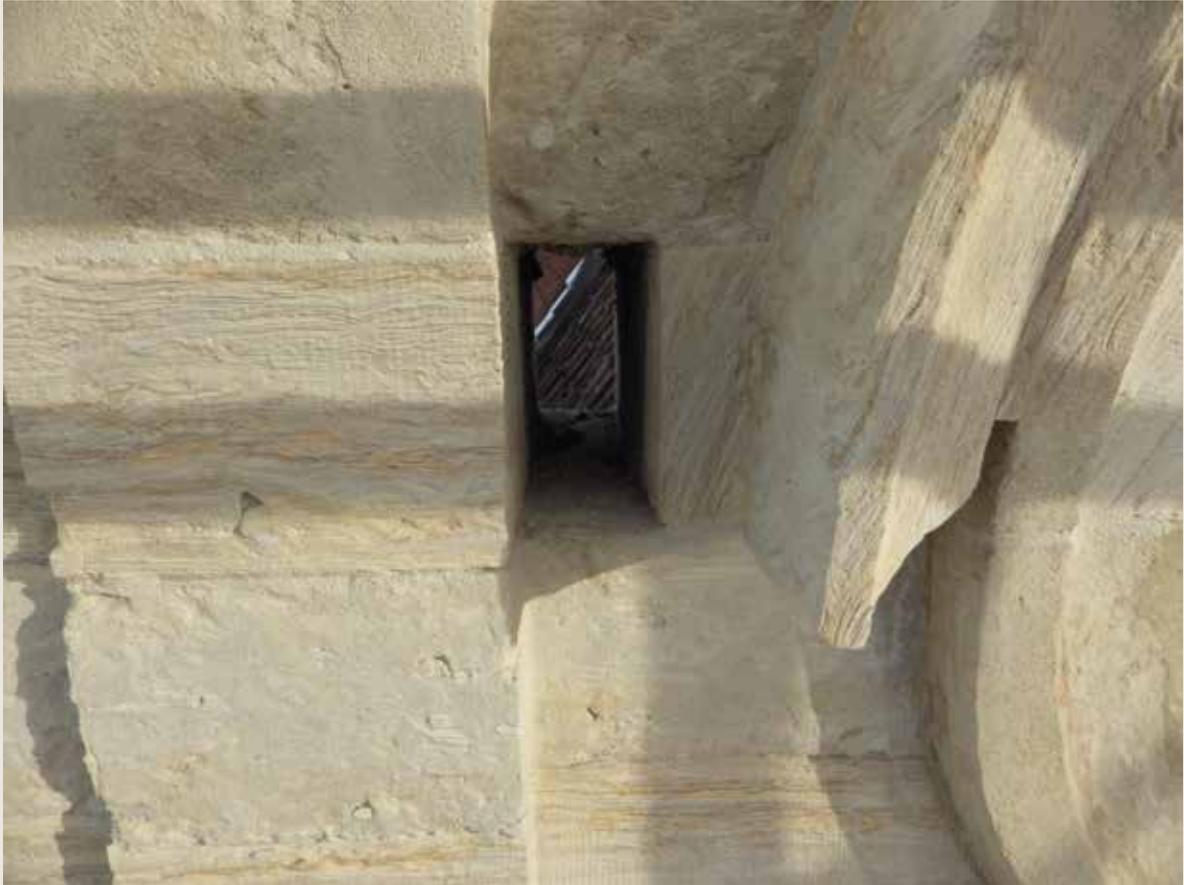
*Le Heume/Den Helm.* Detail of the Gobertange stone gable displaying the bioturbation typical of this stone (© HHU, 2015).

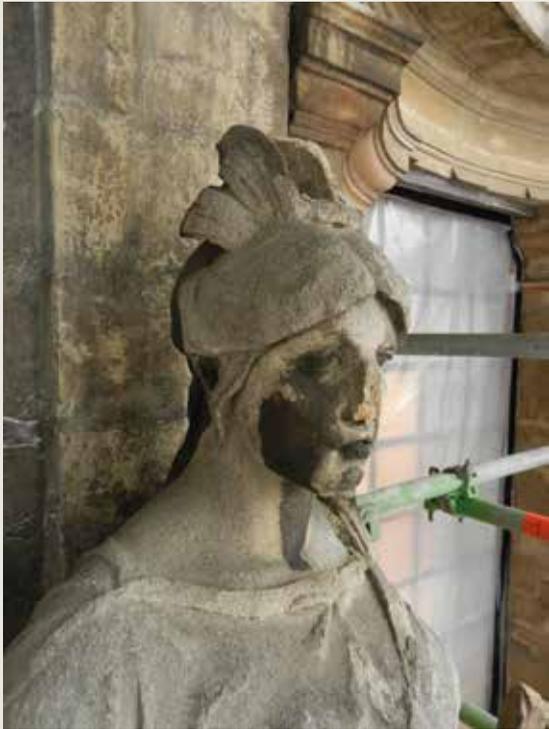
*Le Renard/De Vos.*  
Euville stone.  
Chipping and  
powdering of the  
nose. Black crust  
(© HHU, 2014).

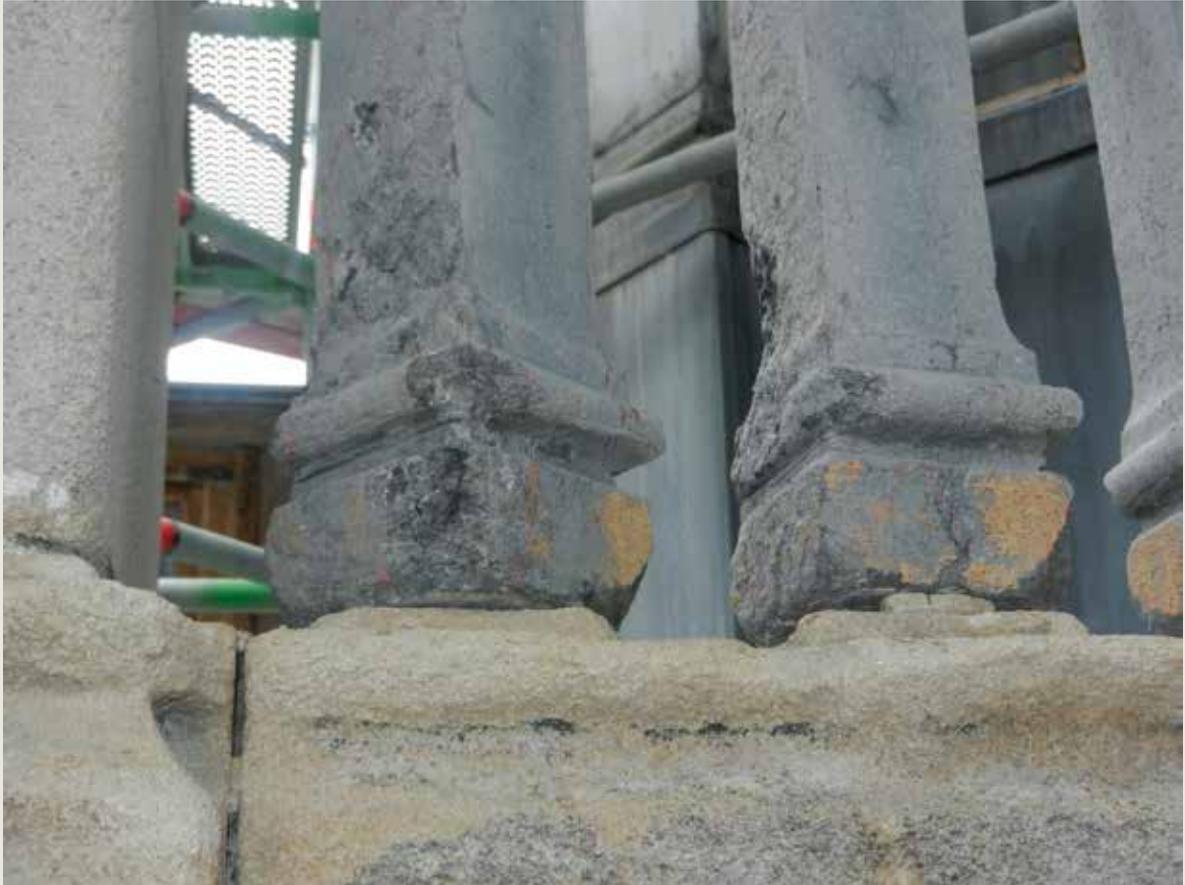
*Le Roi d'Espagne/Den Coninck van Spaignien. Pitting of the stone due to the presence of stylolites and the face-bedding of the stone in the balusters. Blue stone (© HHU, 2014).*

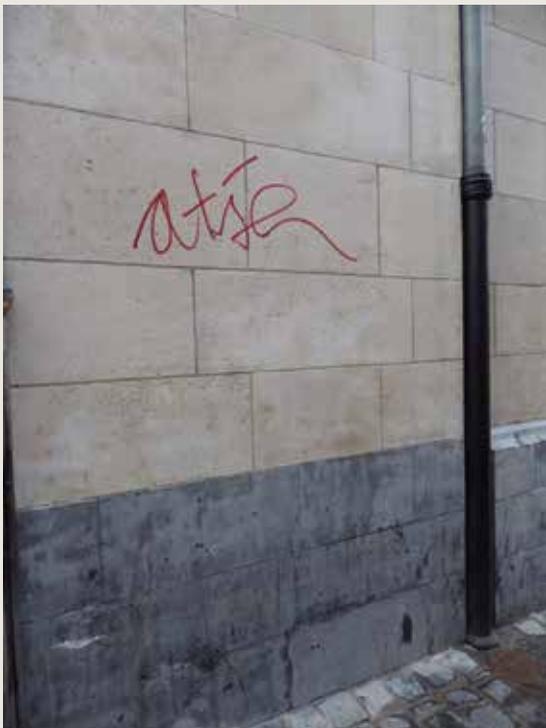
*Le Roi d'Espagne/  
Den Coninck van  
Spaignien. Side  
façade. Presence  
of graffiti. Euville  
stone (© HHU,  
2014).*

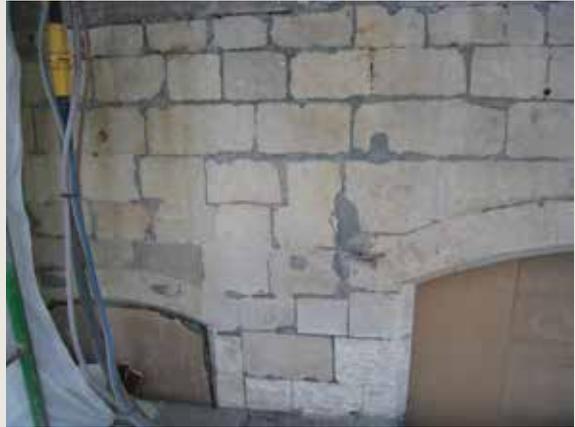
*La Maison des Brasseurs/Het Brouwerhuis.* Cement joints created during previous work (© HHU, 2008).

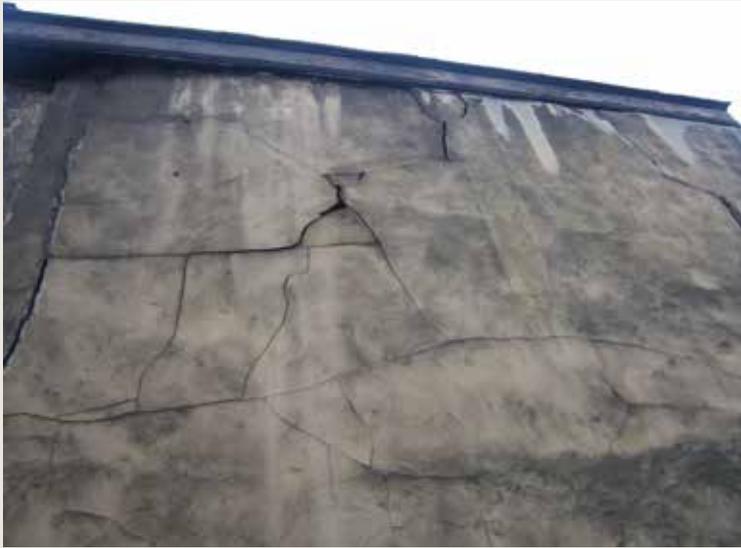
*Le Cygne/De Swane*. Delamination of the coating of the party wall, on the right (© HHU, 2008).

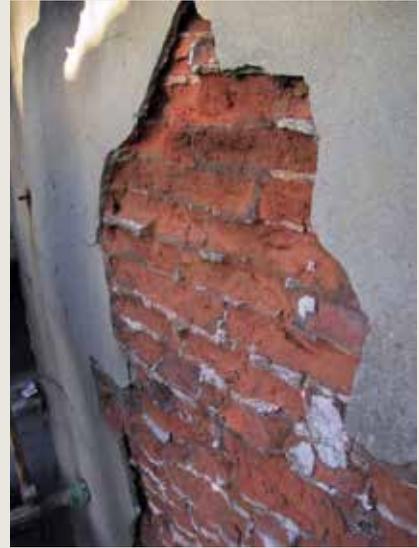
*Le Renard/De Vos*. Delamination of the party wall, on the left (© HHU, 2014).

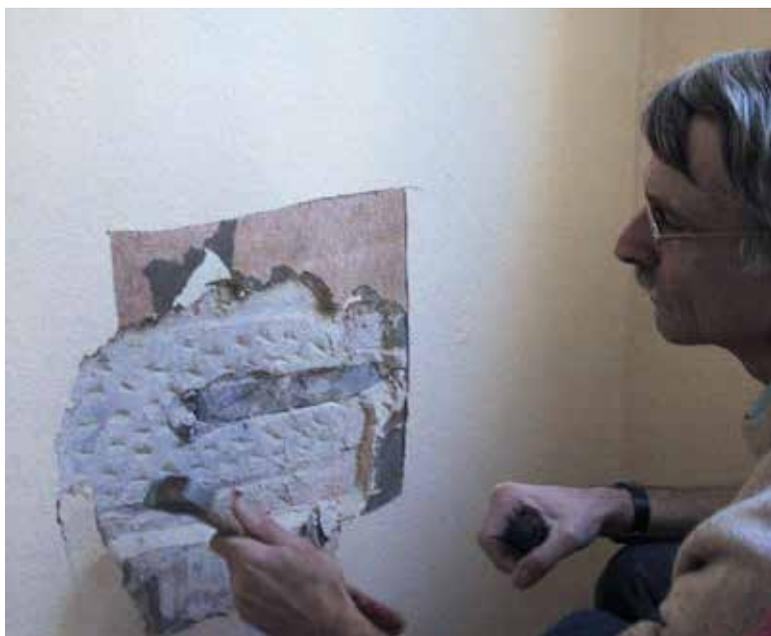
*L'Âne/Den Ezel*. A. Pien removing the render from a party wall to determine the shape of an anchor (© CHE, 2001).

The purpose of these one-off surveys, which were limited to *L'Âne/Den Ezel*, was to complement the material and historical study of the building. Yet they also had a practical and technical aspect. They were intended to determine whether the metal elements, such as bars or anchors, were still effective. However, locating them had highlighted the possible corrosion of elements not spotted during the visual inspection and therefore other potential damage to the stones. The metal detector helped to provide relatively precise information on the number, location and length of the anchors situated inside the house, within the party walls, of which only a few load distribution plates were visible on the external façade.

Next, targeted surveys revealed their exact shape: one wrought iron tip is anchored in lead within a large block of white stone inserted in the brick party wall. At the other end, the rectangular metal plate is rounded with screw threads, which enable the load distribution plate to be attached by means of a bolt. A metallographic analysis helped to determine the composition of the iron, which is relatively pure, some of its properties, such as its hardness, the presence of inclusions and impurities, and even to identify the corrosion products. The anchors were also analysed, revealing lead of a high degree of purity. Additional analyses on the square bars were also carried out on the façade.

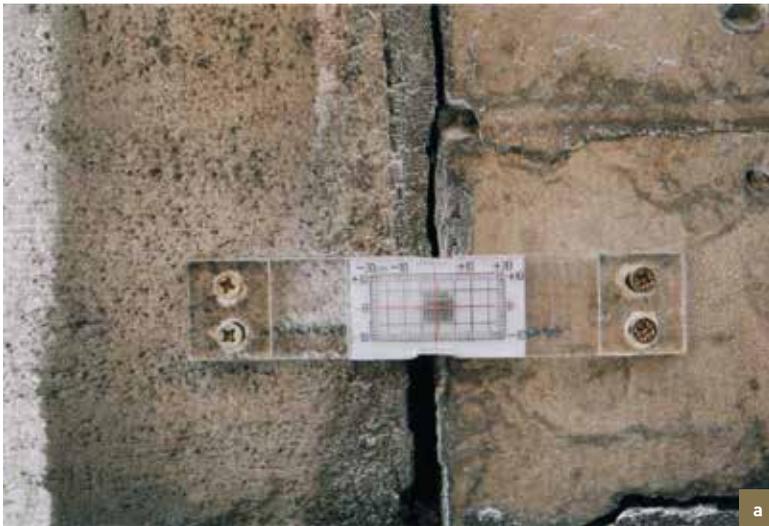
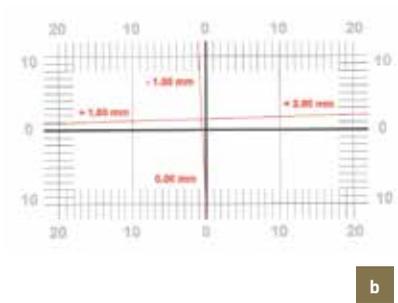
Certain gables were out of plumb by several centimetres. A structural analysis of the buildings, carried out by an engineering firm, confirmed problems with the displacement of the façades due to corroding beams or beam ends, leading to the separation of the stones and

even fracturing. The data from the crack meters installed during the inspections in 2000 showed that the gables had stabilised in the meantime. Nevertheless, the damage caused by the spreading of the rust to the surrounding stones made the dismantling of the gables in each instance necessary, as well as the total replacement of the corroded metal beams responsible for the

*L'Âne/Den Ezel*. a) Crack meter; b) Readings recorded (© HHU, 2002).

problems. This was the case with *L'Âne/Den Ezel*, *La Brouette/Den Cruywagen*, *L'Étoile/De Sterre* and *La Chaloupe d'Or/De Gulden Boot*. On the lower floors, I-beams or square bars also exhibited signs of corrosion requiring them to be replaced, as with *Le Cerf/ De Heert*, *Le Paon/ Den Pauw*, *Sainte-Barbe/Sint Barbara* and *Le Roi d'Espagne/Den Coninck van Spaignien*.

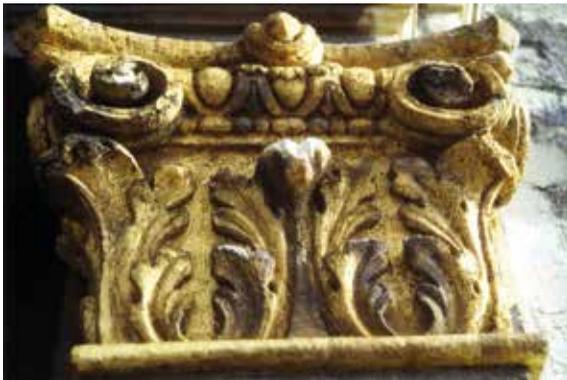
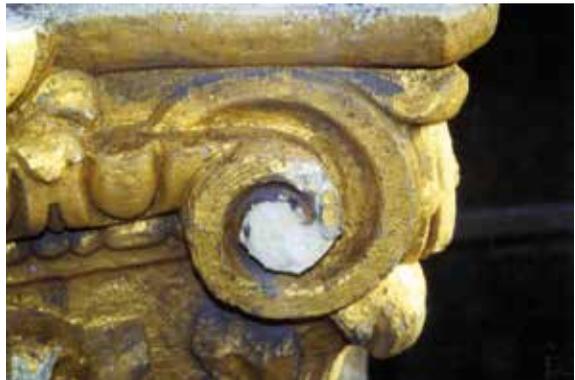
On this same house, identifying the white stone used for the gilded capitals proves to be more problematic. The cracks or chips need to be examined in order to get an idea. Contrary to the archive documents, which suggested that the capitals had been replaced with Balegem or Gobertange stone, the building as it stands could lead one to identify the material as French Avesnes stone, which we know was also used on the Grand Place for certain decorative elements. Indeed, the capital examined reveals a chalky, finely-grained and relatively soft stone rich in glauconite crystals. Certain

*L'Âne/Den Ezel. Inspection of capitals by Francis Tourneur. Most likely Avesnes stone (© HHU, 2002).*

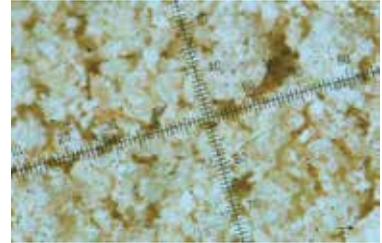
Echantillon	M1	M4
Perte au feu 540 °C	4.74 %	4.68 %
Perte au feu 1050 °C	13.11 %	12.39 %
Résidu insoluble	57.7 %	64.76 %
SiO <sub>2</sub> soluble	2.6 %	2.37 %
CaO	18.48 %	17.85 %
Total	91.89 %	97.37 %
CO <sub>2</sub>	10.46 %	4.05 %
Densité apparente (kg/m <sup>3</sup> )	1629	(impossible de déterminer)
Volume des pores (% en volume)	30.3

Analysis of mortars in a laboratory (© KU Leuven, 2001).

Cement-lime mortars were used, comprising around 200 kg of Portland cement (between 188 kg and 207 kg) and 240 kg of hydrated lime (between 242 kg and 244 kg) per m<sup>3</sup> of sand, with a relatively high porosity of 30% of the volume.

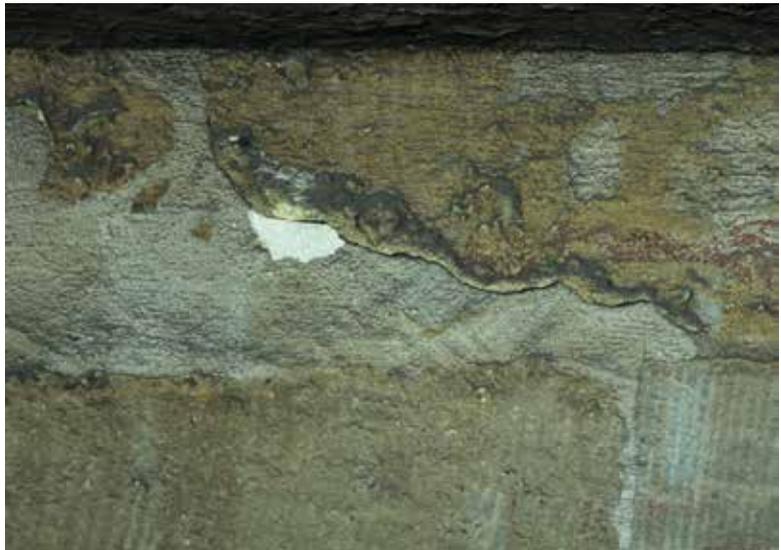
*La Maison des Brasseurs/Het Brouwerhuis*. Sampling of repair mortar (© HHU, 2002).

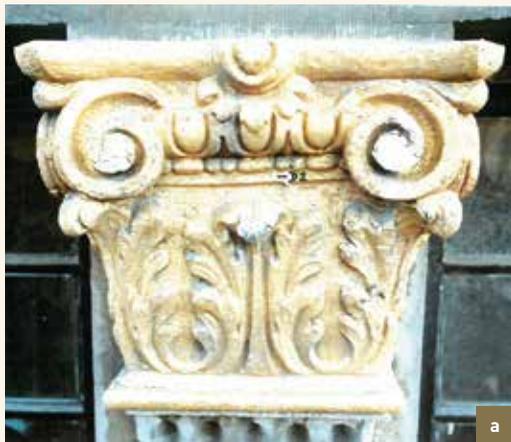
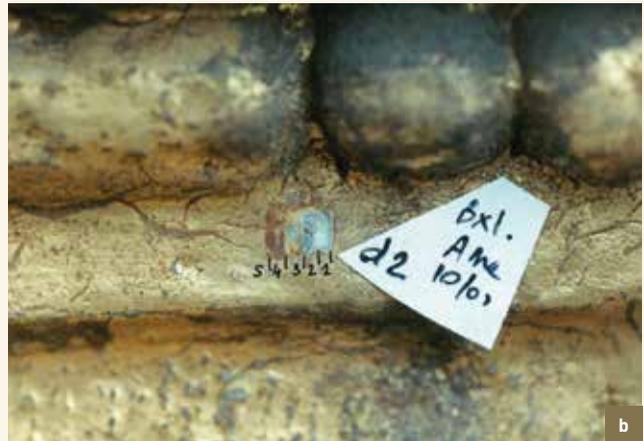
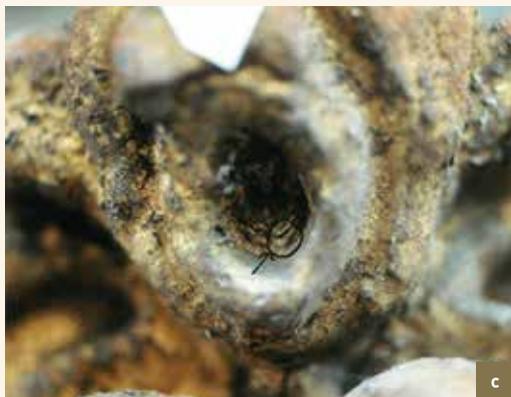
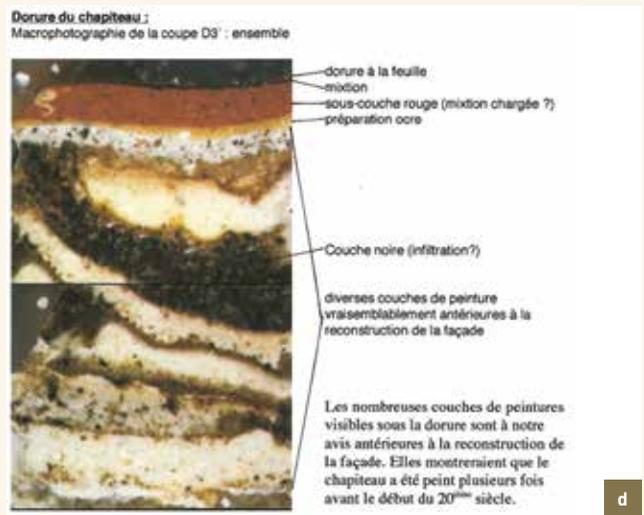
*L'Âne/Den Ezel.* a) View of a capital with stratigraphic sampling (© M. Decroly, 2002); b) Detail of stratigraphic sampling D2. 1. Stone. 2. Black layer (sealer or black crust). 3. Ochre mix. 4. Red undercoat. 5. Gilding on mixtion (© M. Decroly, 2002). c) View of the volute of a capital with sampling D3 (© M. Decroly, 2002); d) Macro photograph to see different layers of paint, suggesting that the capital has been recovered (© KIK-IRPA, 2002).

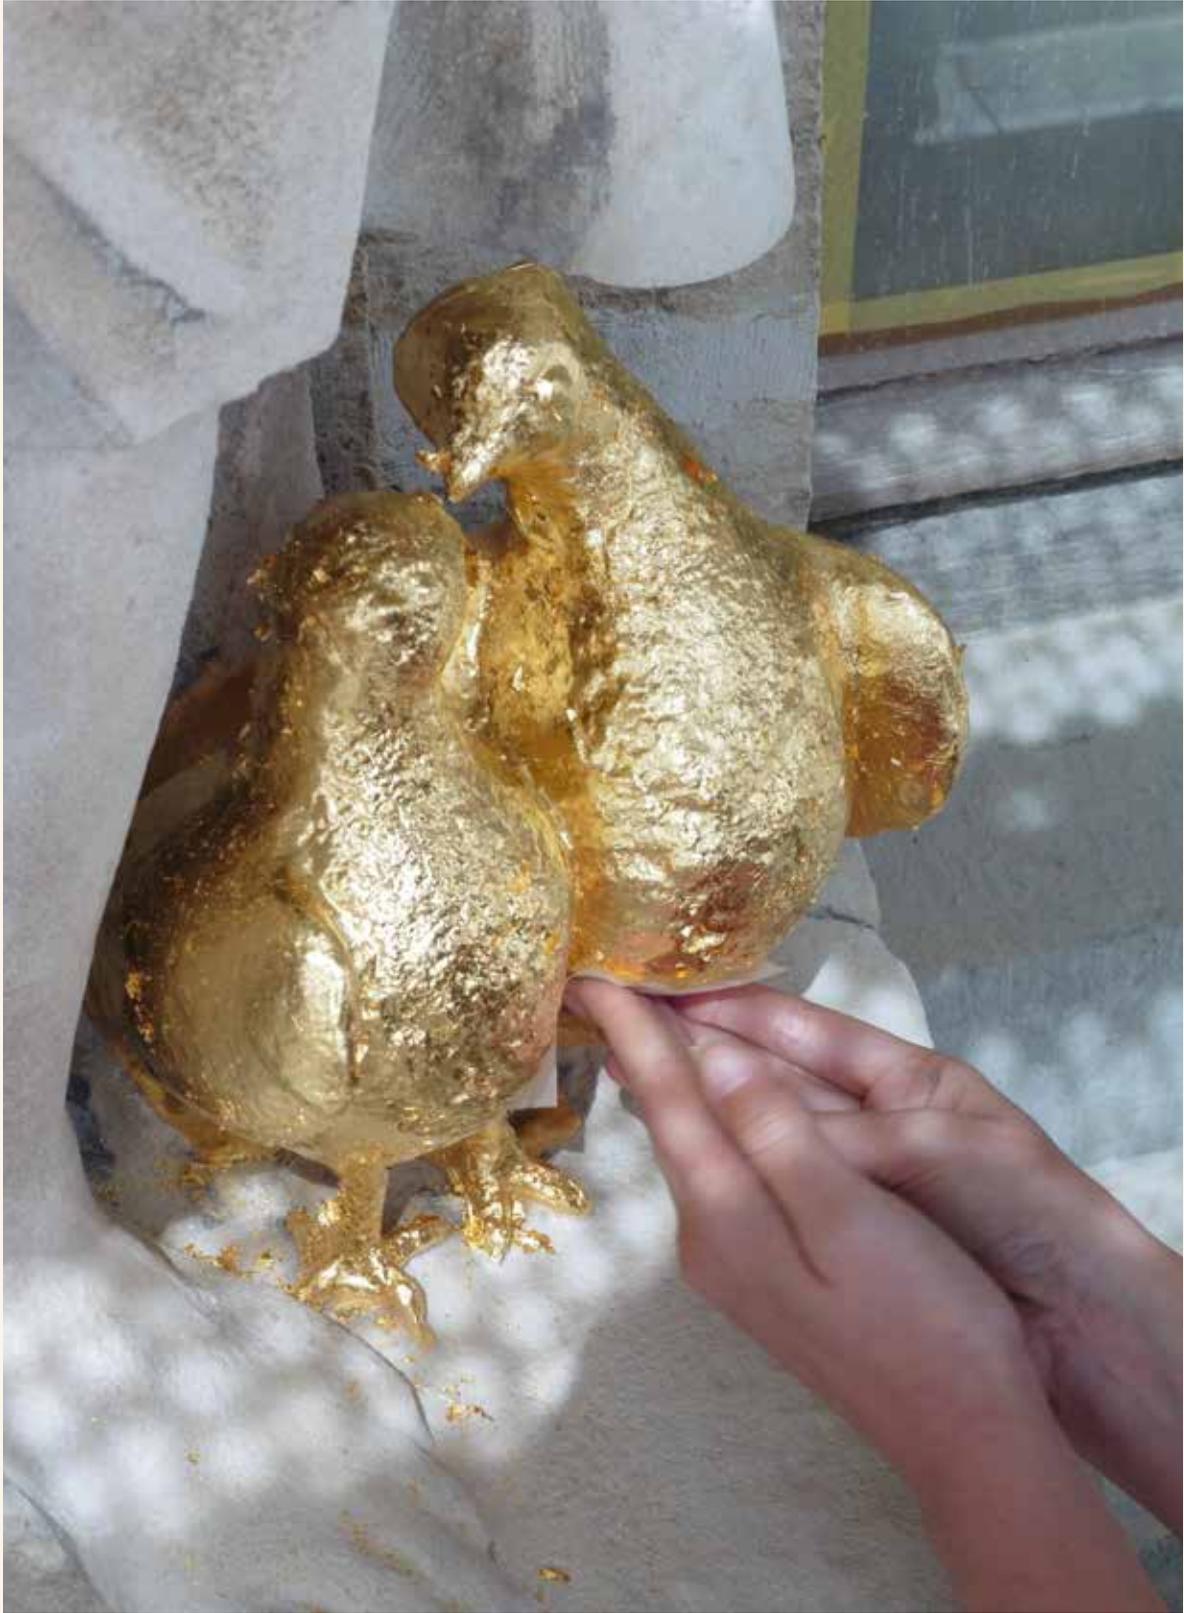
*La Louve/De Wolvin*. Detail of doves from the sculpture *La Paix/De Vrede* (Godefroid Vanden Kerkhove, 1872). Gilding in progress. Savonnière stone (© HHU, 2015).
